REQUEST FOR QUALIFICATIONS
GENERAL CONTRACTOR /
CONSTRUCTION MANAGER SERVICES

ROMNEY HALL RENOVATION
MONTANA STATE UNIVERSITY
Bozeman, MT

A/E #2012-02-14; MSU PPA #16-0164

NOVEMBER 2016

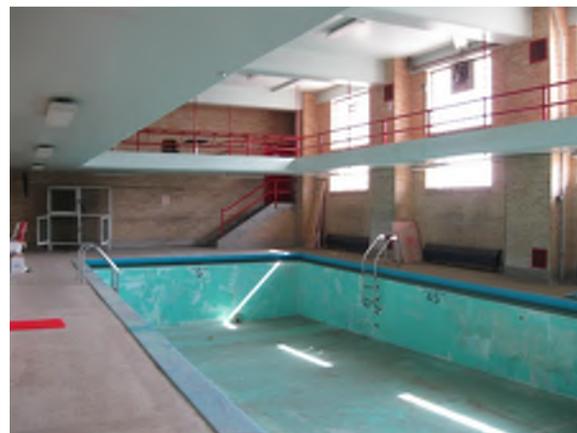
Romney Hall – Unusable Pool

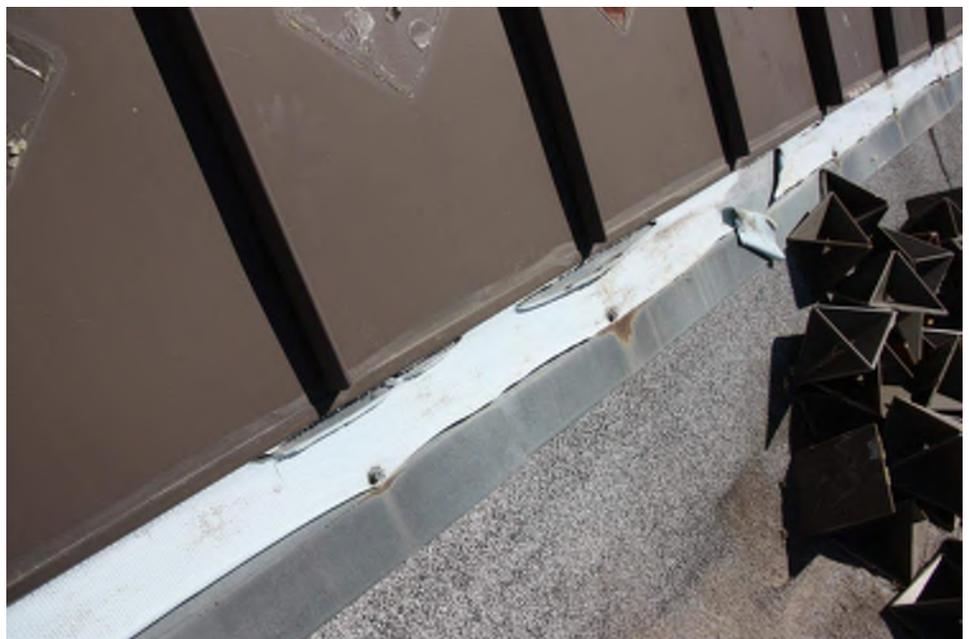
Figure 26: The reinforced membrane lapped at the base of the sheet metal is often torn, broken down by UV rays.

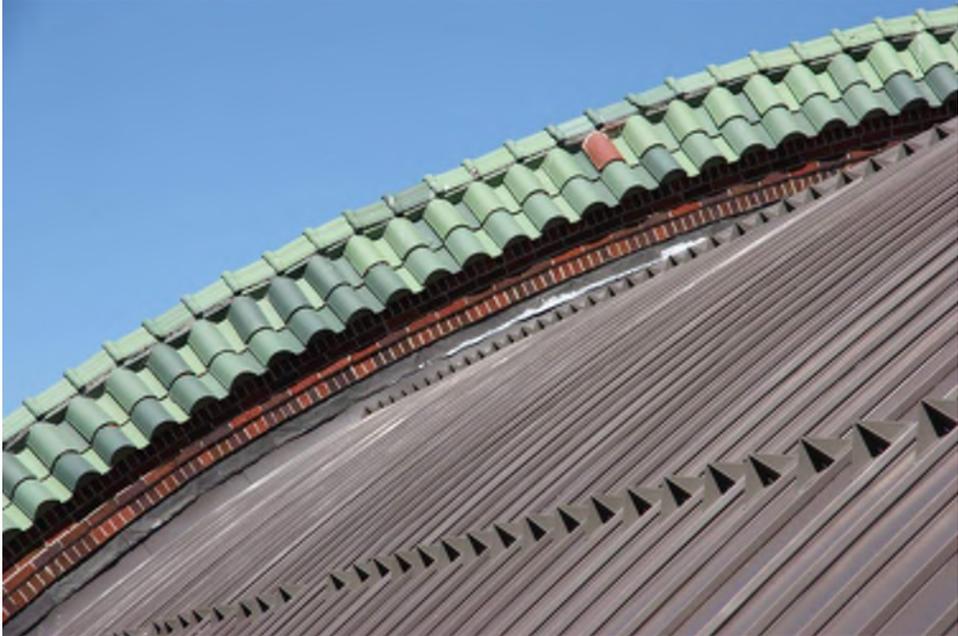
Figure 27: Painted flashing at the parapet walls appears to be in good condition.

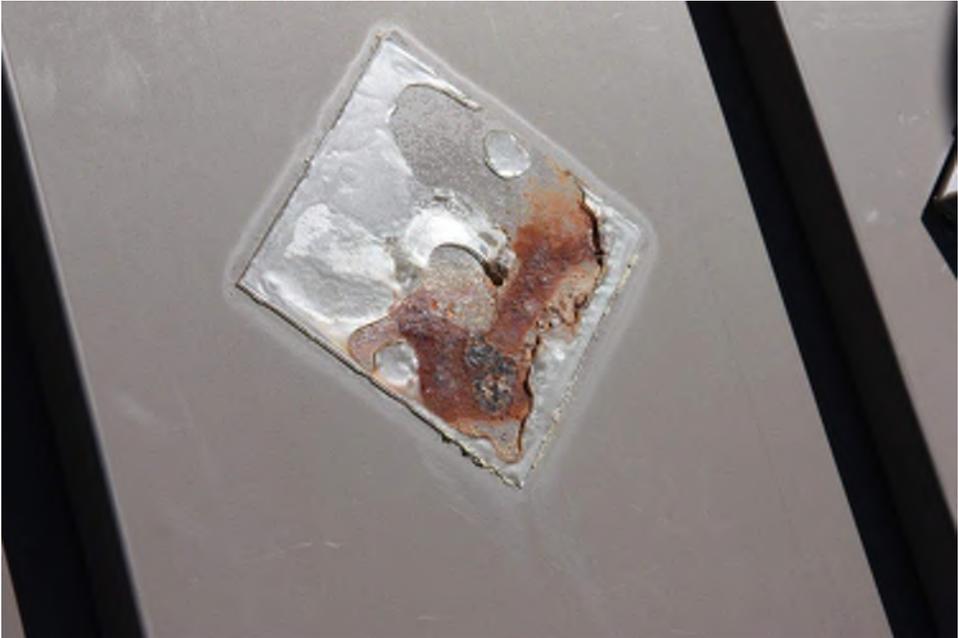
Figure 28: Rust is forming where moisture was trapped under a snow guard, since fallen.

The rusted areas should be treated to remove the rust and repainted with a system compatible with the Kynar coating. This scope of work will constitute more than the fallen snow guards, as rust is developing at other guards that still remain in place. The snow guards should be reinstalled. The skyward sealant at all the snow guards should be replaced; sealant

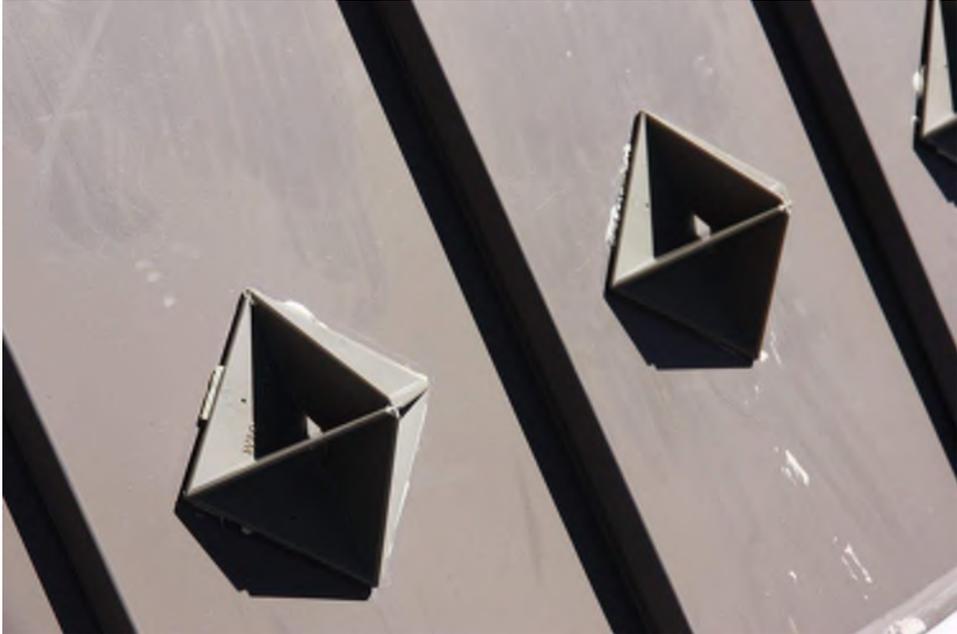
Figure 29: Sealant failure at the skyward side of the snow guards allows moisture to travel behind the snow guard.

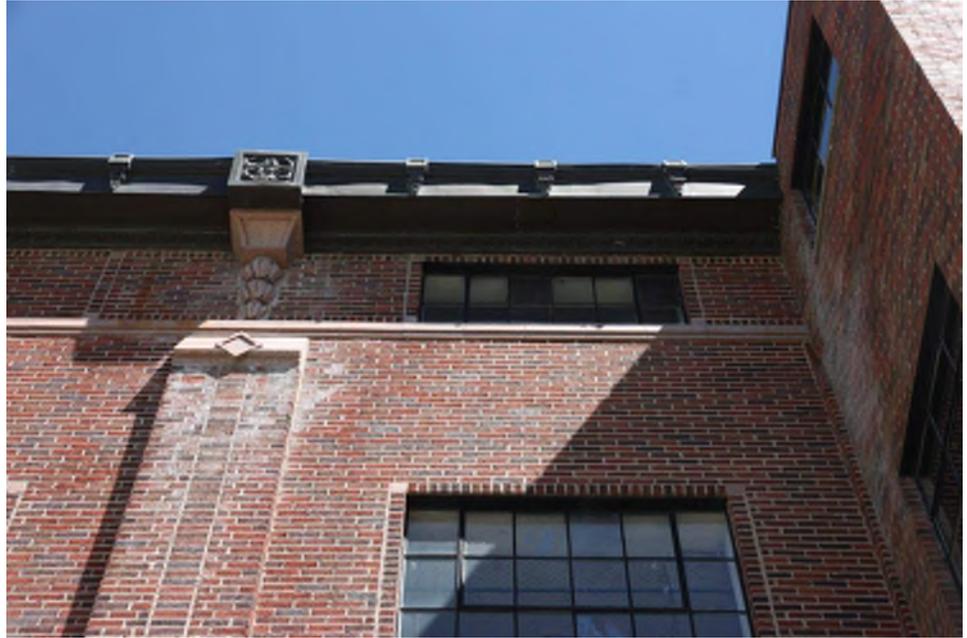
Figure 33: Gaps in the sheet metal seams of the cornice-to-gutter system, and at the liner seams are probably causing moisture penetration into the walls below.

Plaster patch at ceiling could be attributed to water damage from the gutter or from leaking joints at the roof vents (see Roof Penetrations below).

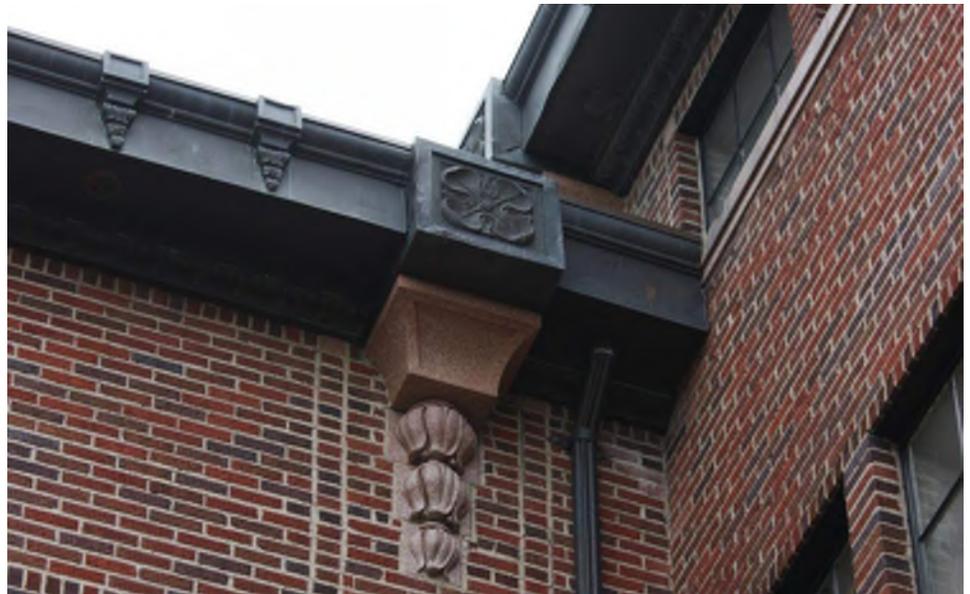
Figure 36: Open seams in the gutter liner or the sheet metal have allowed moisture to penetrate the masonry wall below.

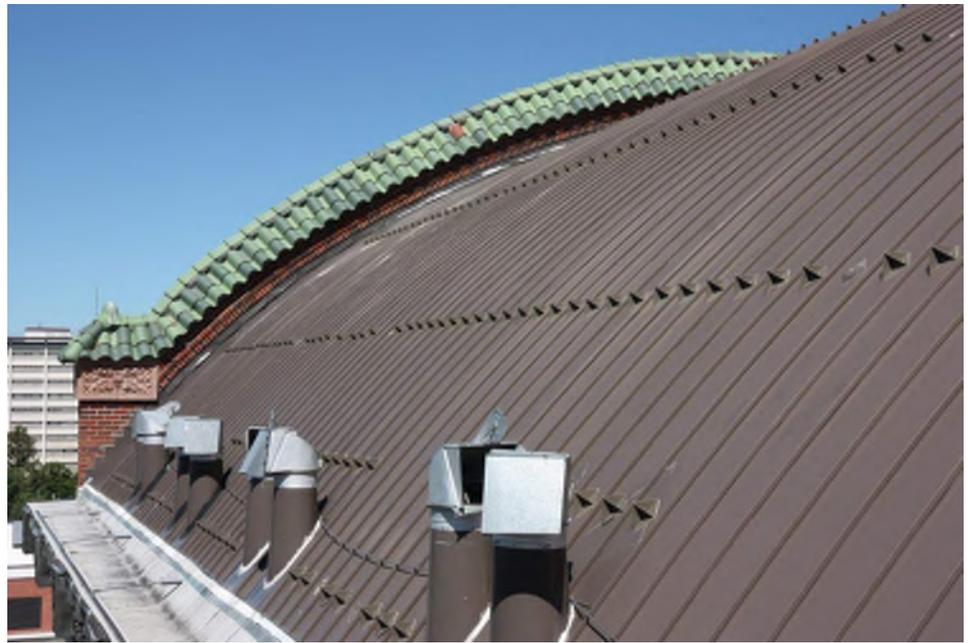
Figure 39: Several of the vent flaps are missing.

Provide flaps where missing at the ventilator caps. Remove all the sealant, confirm proper

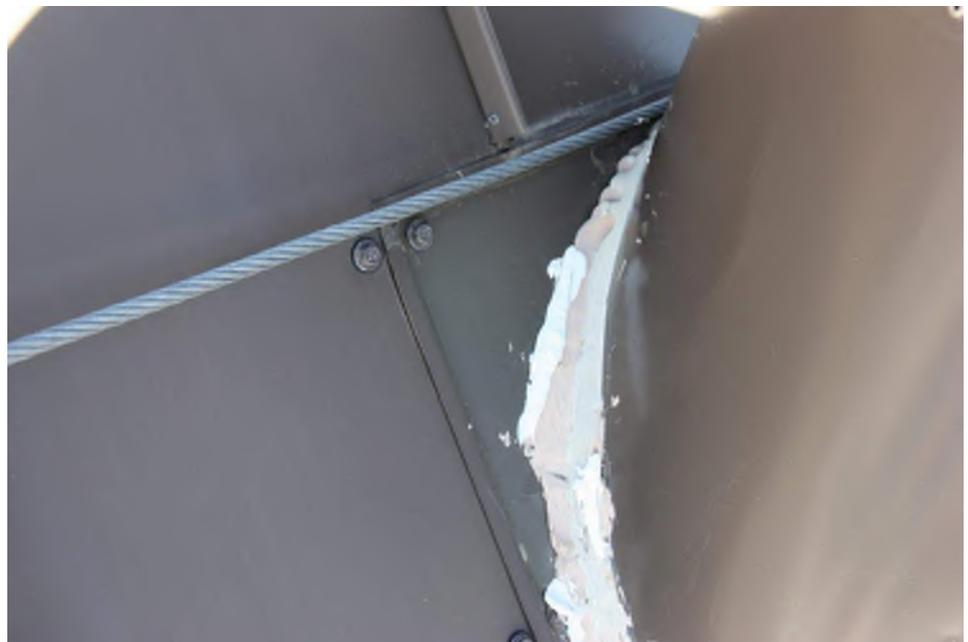
Figure 40: A regular application of sealant at the upslope side of each ventilator has been required to reduce water penetration.

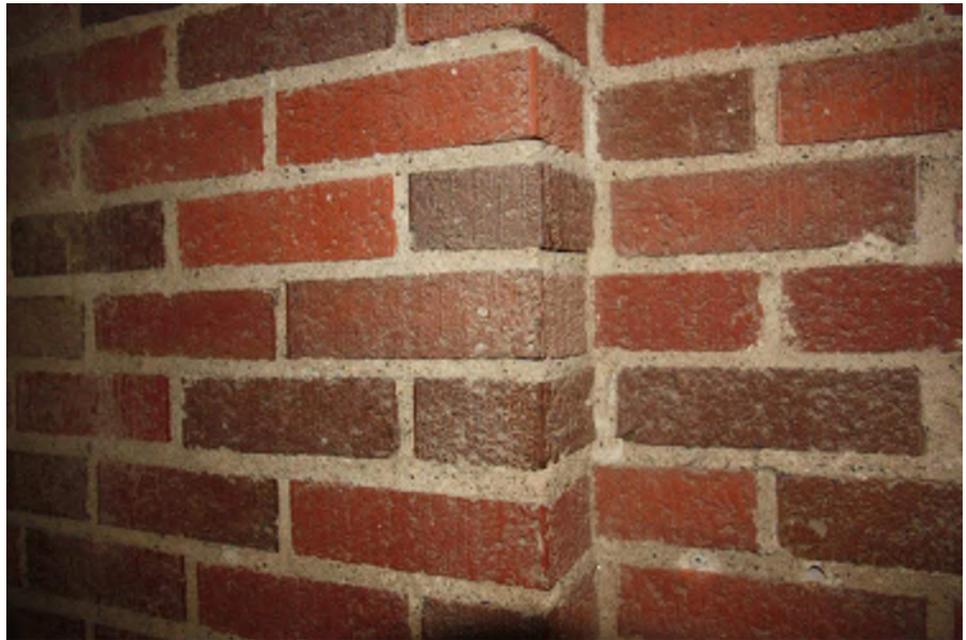
Figure 45: Most of the mortar joints are original and in excellent condition.

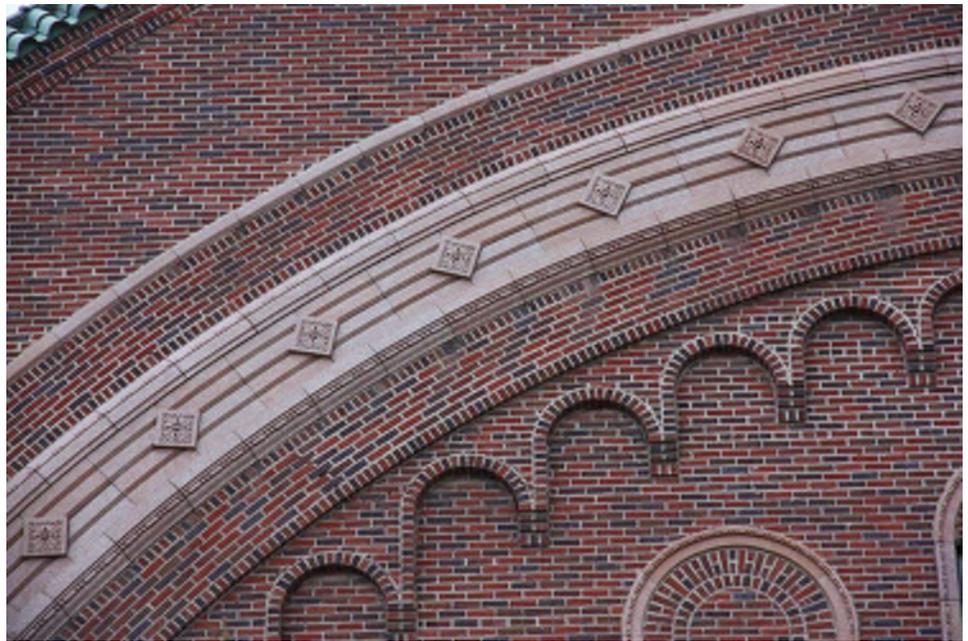
erosion at brick below terra cotta units, where the joints have failed. A second area of typical erosion is at the skyward joints of the beltcourse. While the beltcourse adds visual interest to the building, it is problematic in terms of detailing. The beltcourse extends beyond the upper wall plane, exposing the horizontal surface of the joints to snow, ice, and water penetration. Provision of a sloped concrete wash at the top of the beltcourse was helpful initially, yet now water is directed into the vertical joints below. Most of the top rowlocks of the beltcourse have been repointed, seemingly with a hard mortar, trapping water within the brick itself, causing extraction of salts onto the wall surface. Where salts have remained in the brick, they have frozen and exerted enough pressure to spall the outer surface of the masonry unit off (exposing the more

Figure 47: There is a regular pattern of open mortar joints in the terra cotta trim causing open mortar joints in the brick directly below.

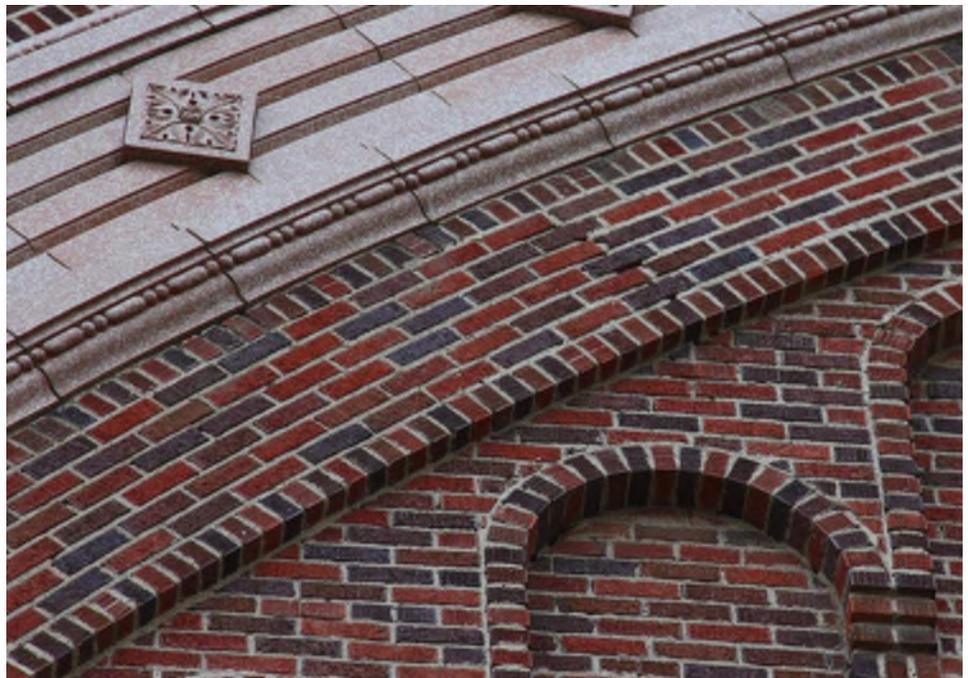
Figure 48: Close-up of open joints in brick below terra cotta trim.

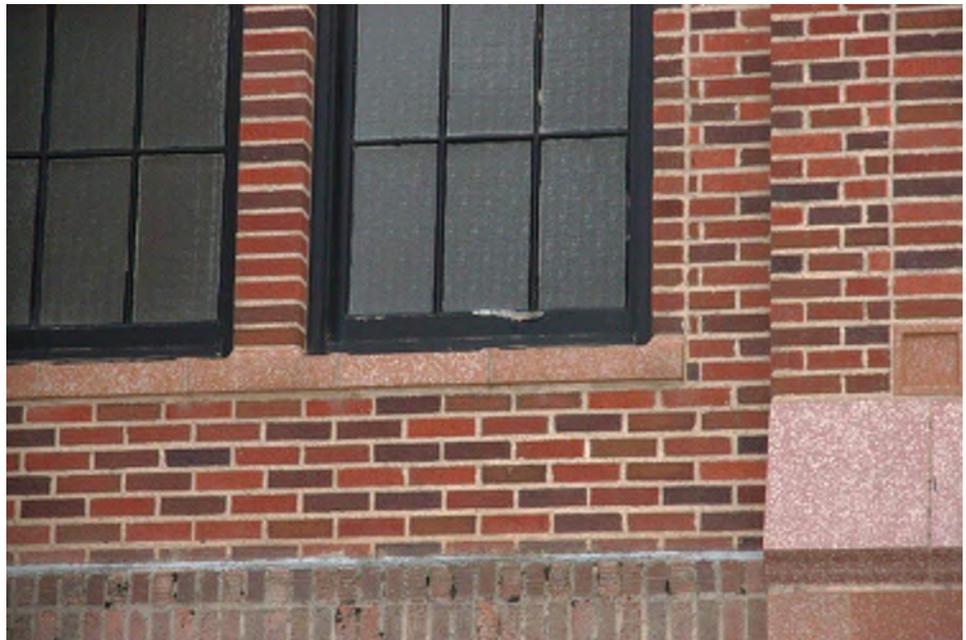
Figure 49: The beltcourse is vulnerable to water penetration, resulting in mortar loss and organic growth.

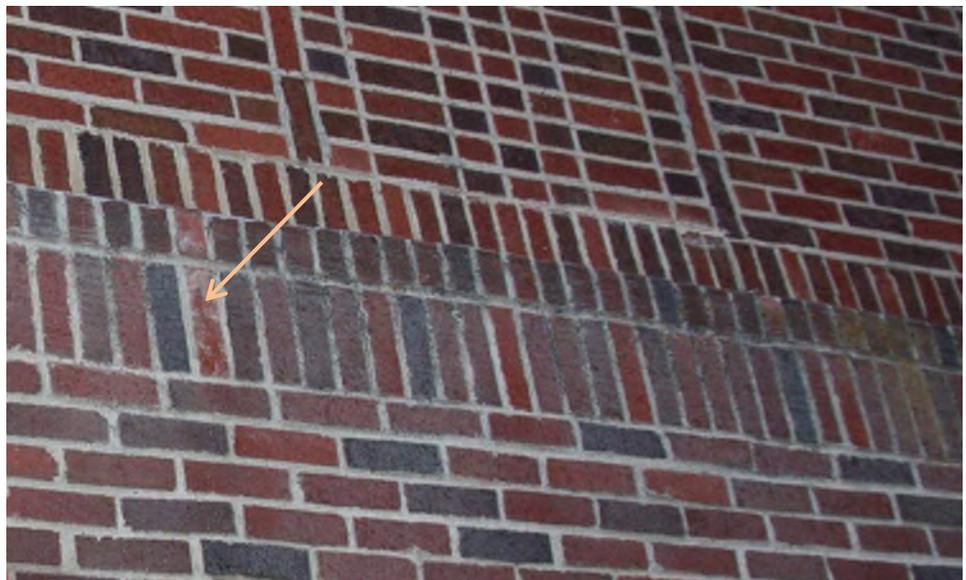
Figure 50: Soldier brick on the west face of the building has spalled (see arrow tip).

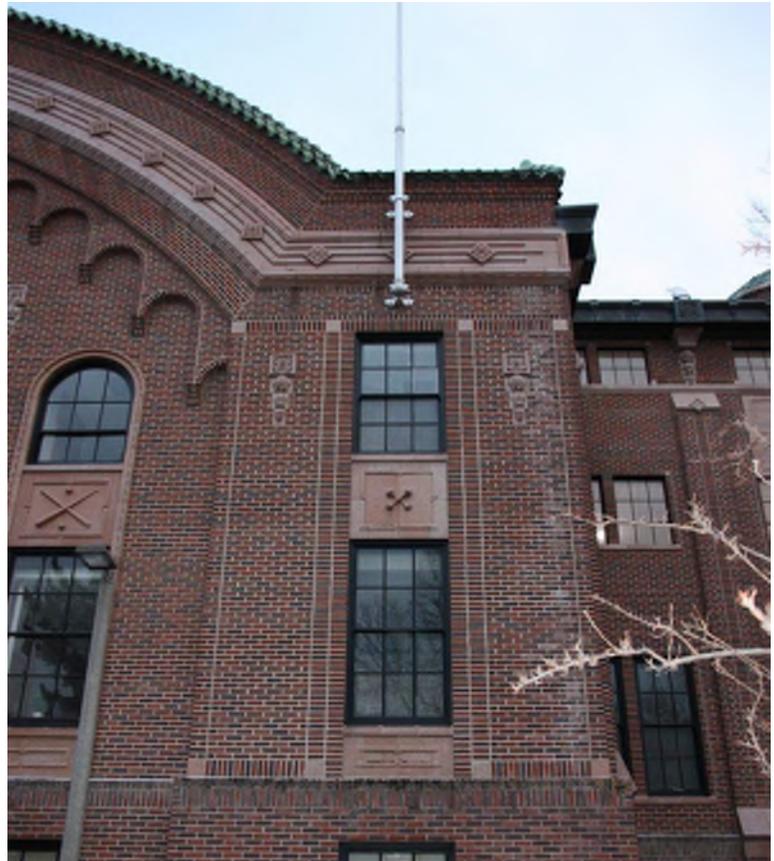
Figure 51: Efflorescence salts are accumulating at the northwest corner of the entry bay; water is entering through leaks in the gutter above.

The joints in the gutter systems need to be sealed.

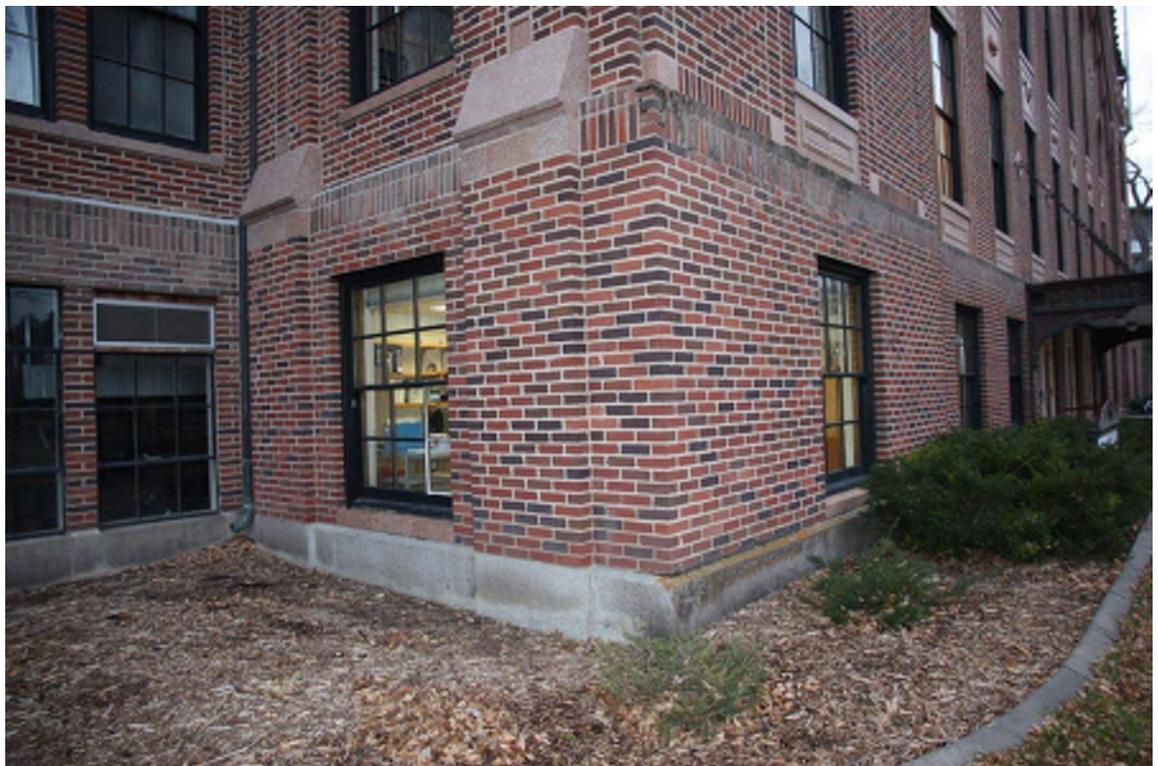
Figure 52: Vegetative growth is most prevalent at the horizontal surfaces of the north face of the building.

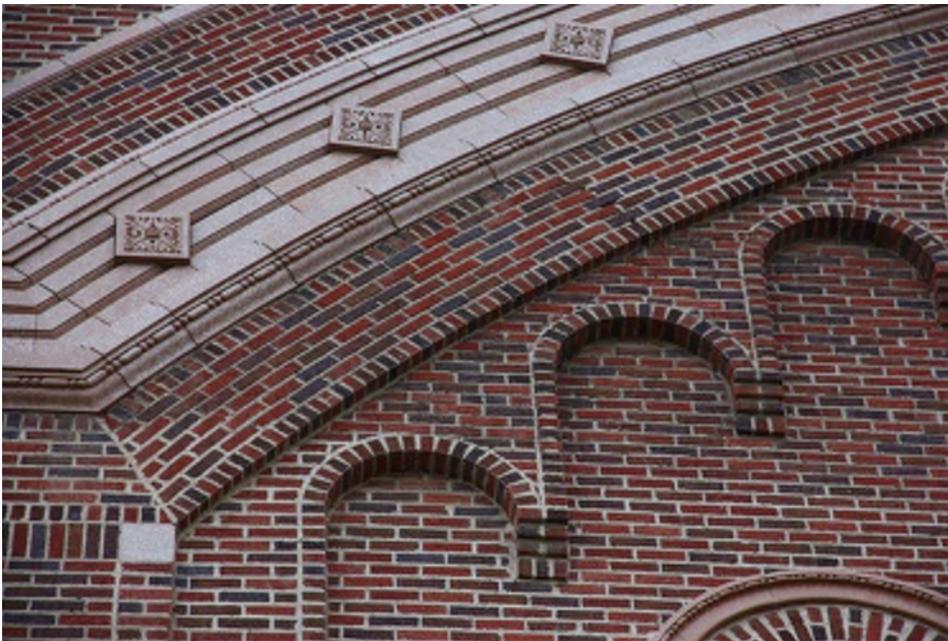
Figure 62: Open joints in the terra cotta arch units impact the condition of the brick below.

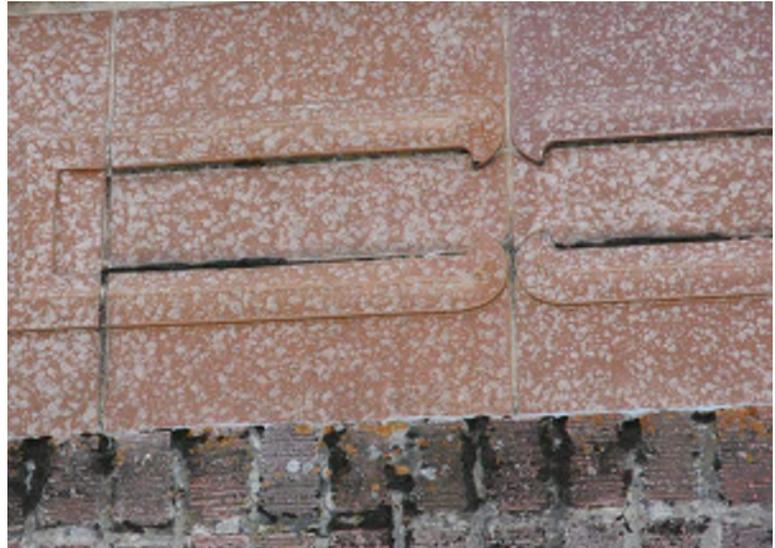
Figure 64: Moss on the north face terra cotta holds moisture against the mortar, causing eventual erosion.

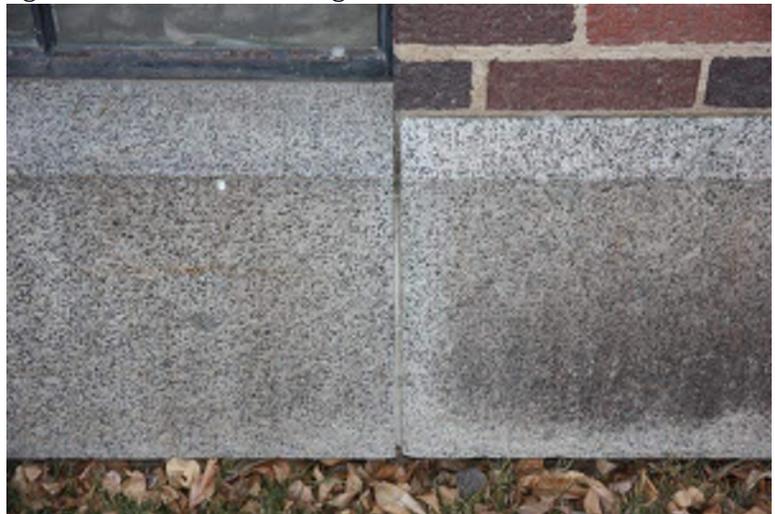
Figure 65: A number of the vertical joints between the granite base units are open.

Clean the granite to remove soiling, moss, and lichen. Repoint the open

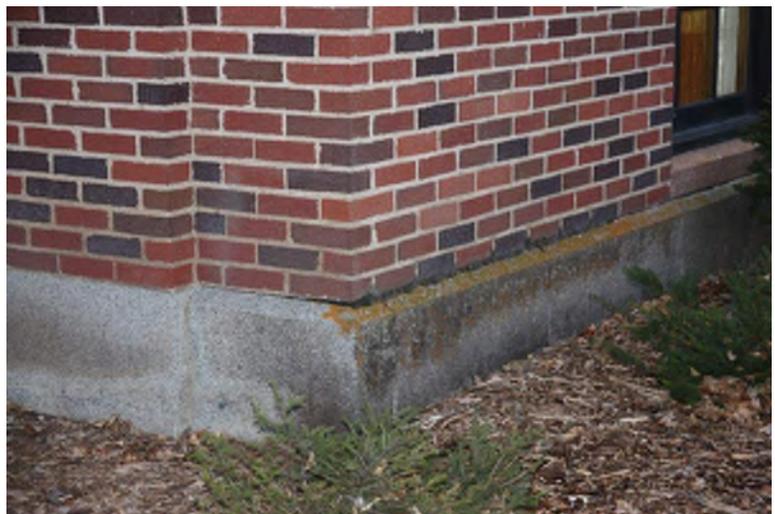
Figure 66: Lichen, moss, and dirt trap moisture against the granite base at the north façade.

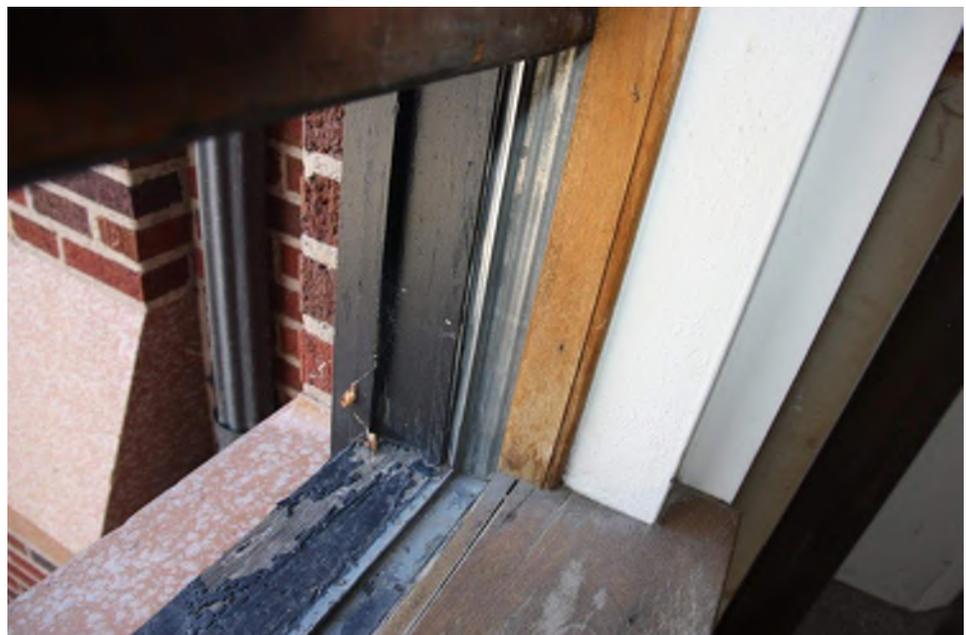
Figure 70: Typical condition, with paint wear at exterior sill and interior stool. Original zinc weatherstripping at jambs, sill, and meeting rails makes the system more airtight.

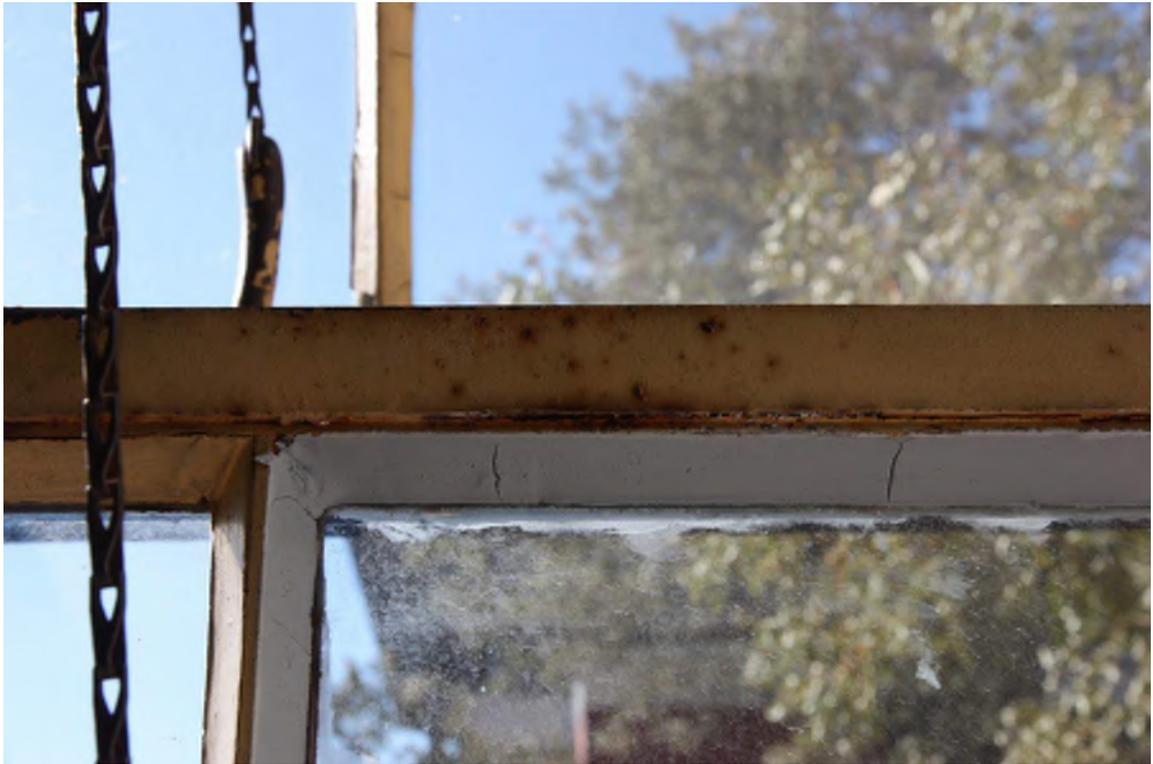
Figure 78: The glazing putty is at the interior, making touch-ups easier. Surface rust is typical for the sash in the locker rooms.

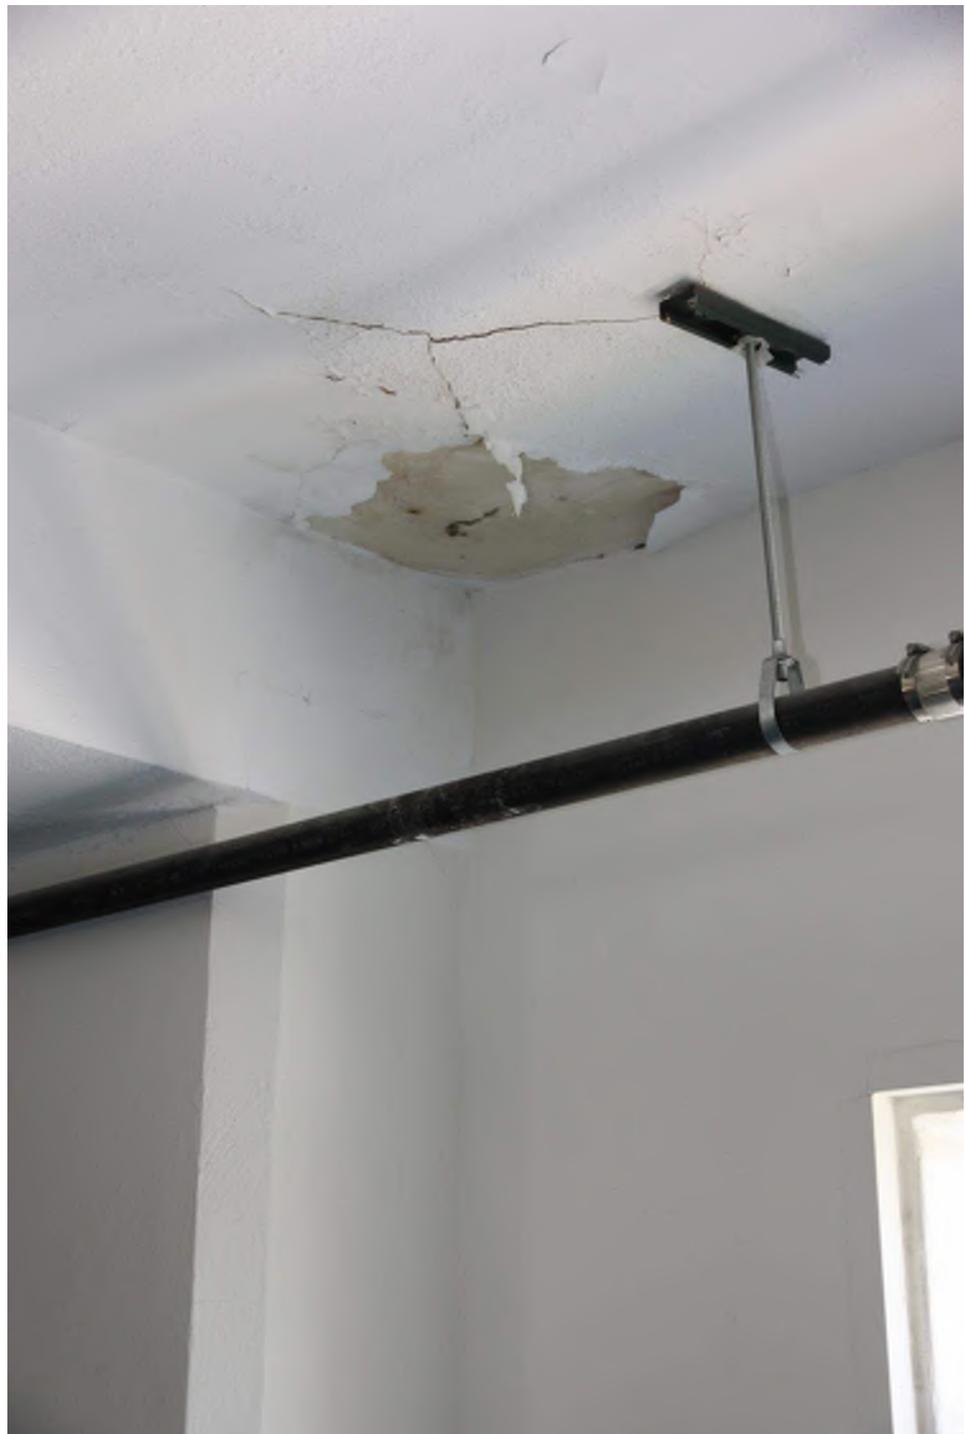
Figure 83: Plaster failure at Main Gym ceiling below roof ventilator.

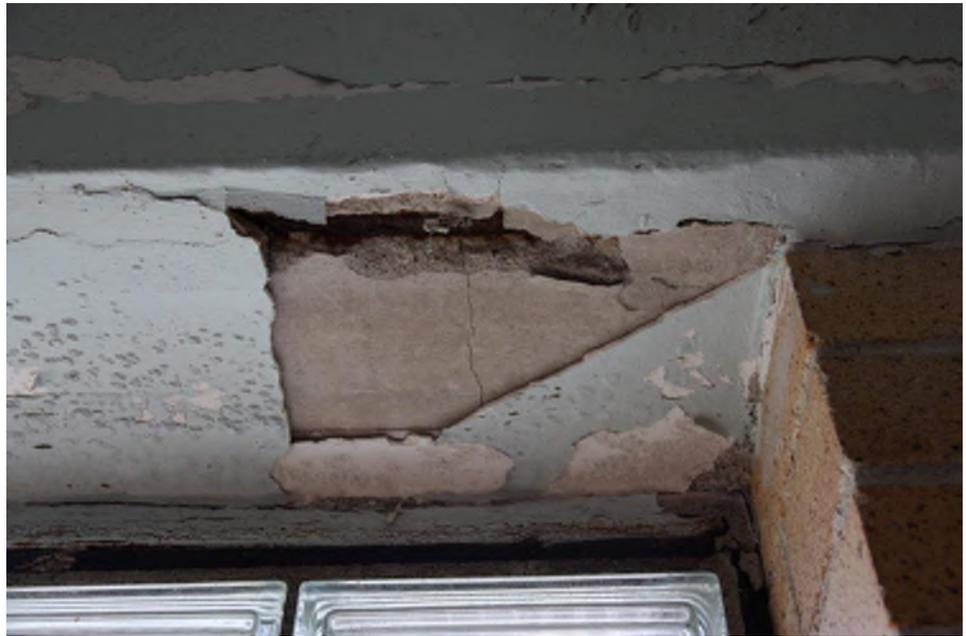
Figure 84: Looking up at plaster head of Pool Room glass block window. Plaster topcoat has delaminated and metal lath has rusted.

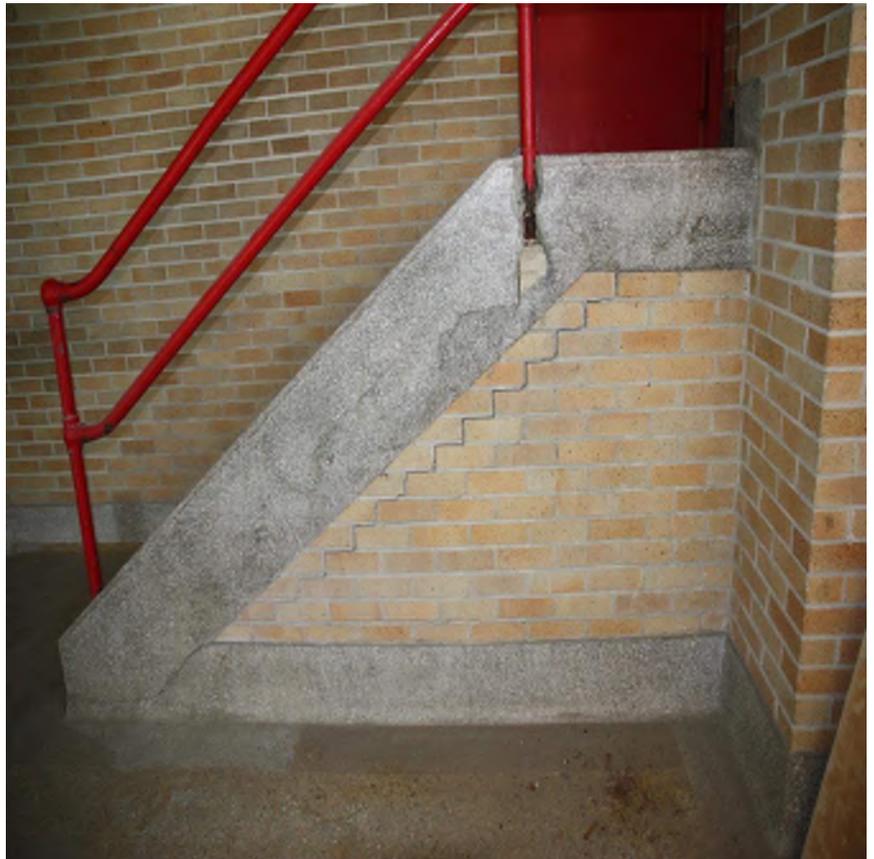
Figure 97: The stair structure at the east end of the pool has settled with the pool slab.

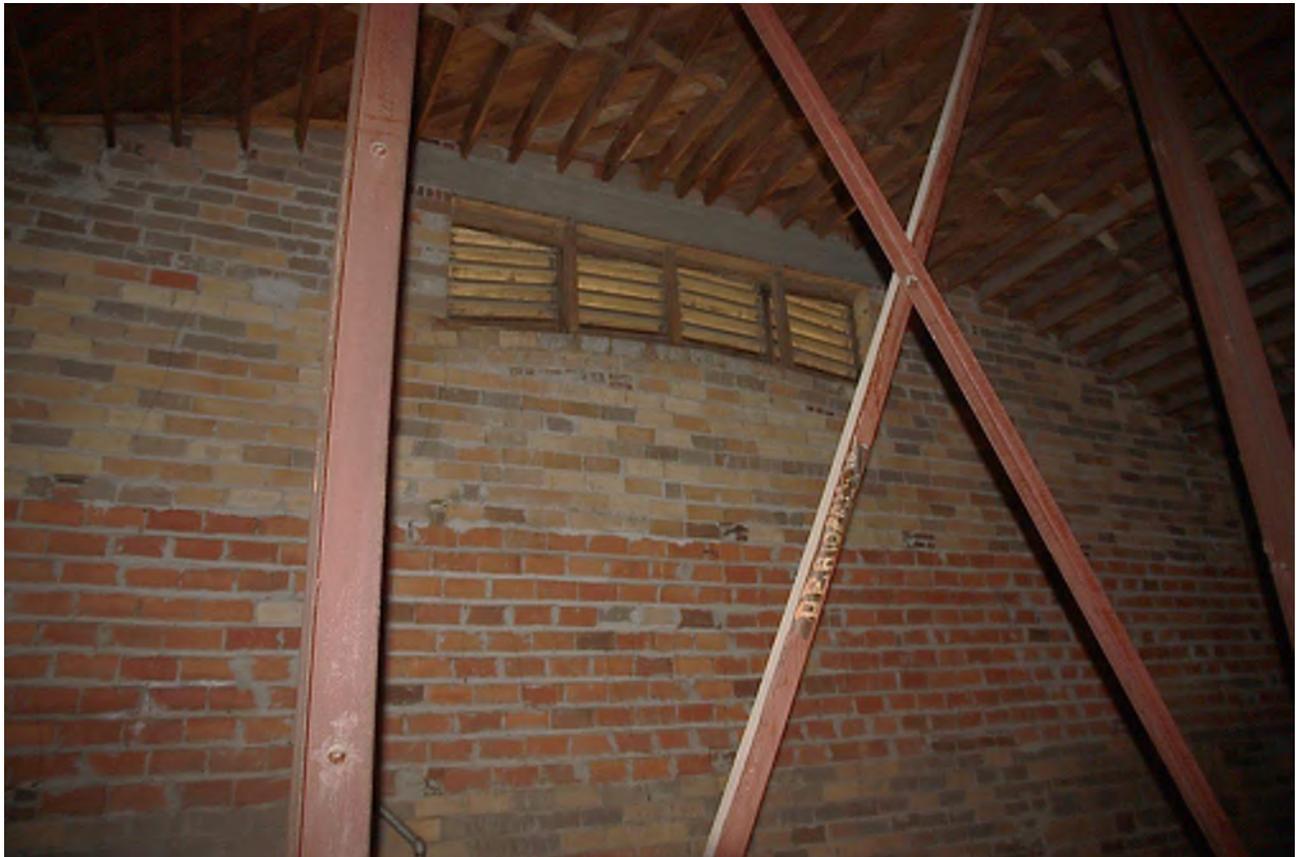
Figure 105: The gable end brick walls are too slender to prevent collapse in a seismic event.
