REQUEST FOR QUALIFICATIONS
GENERAL CONTRACTOR /
CONSTRUCTION MANAGER SERVICES

ROMNEY HALL RENOVATION
MONTANA STATE UNIVERSITY
Bozeman, MT

A/E #2012-02-14; MSU PPA #16-0164

NOVEMBER 2016

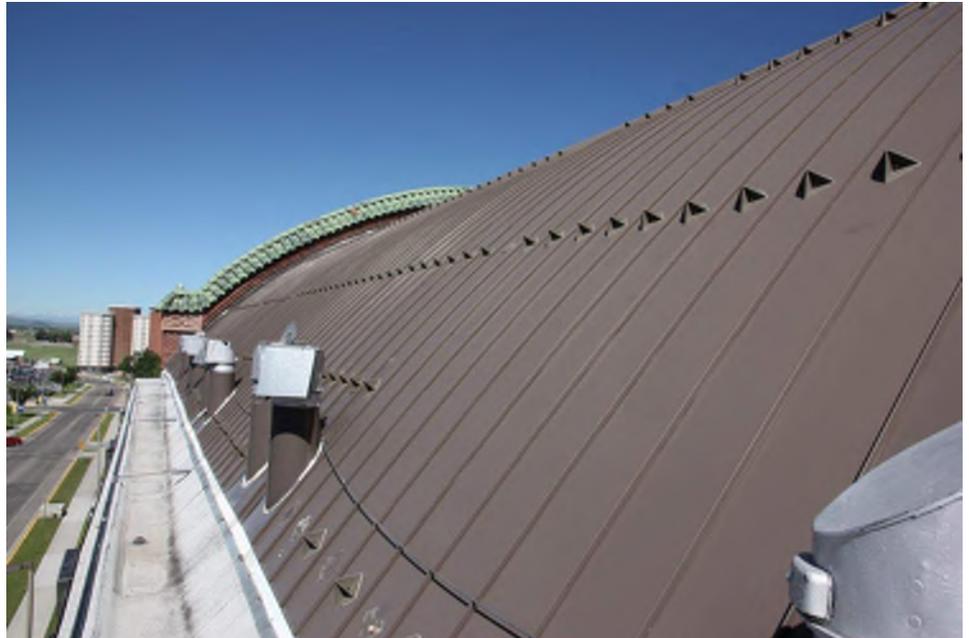
The sheet metal, seams, and finish are in good condition. The single ply reinforced membrane used at the base of the barrel is ripped and degraded from UV exposure. It is assumed that where concealed by the sheet metal, it is sufficiently protected from damaging UV rays. A number of the snow guards – about five to seven per row – have disengaged from the roofing; a pile of fallen guards rests near the roof access. Rusted scars remain where some of the guards were located. Sealant at the skyward side of the guards is degraded.

Figure 25: The standing seam roofing, looking west.

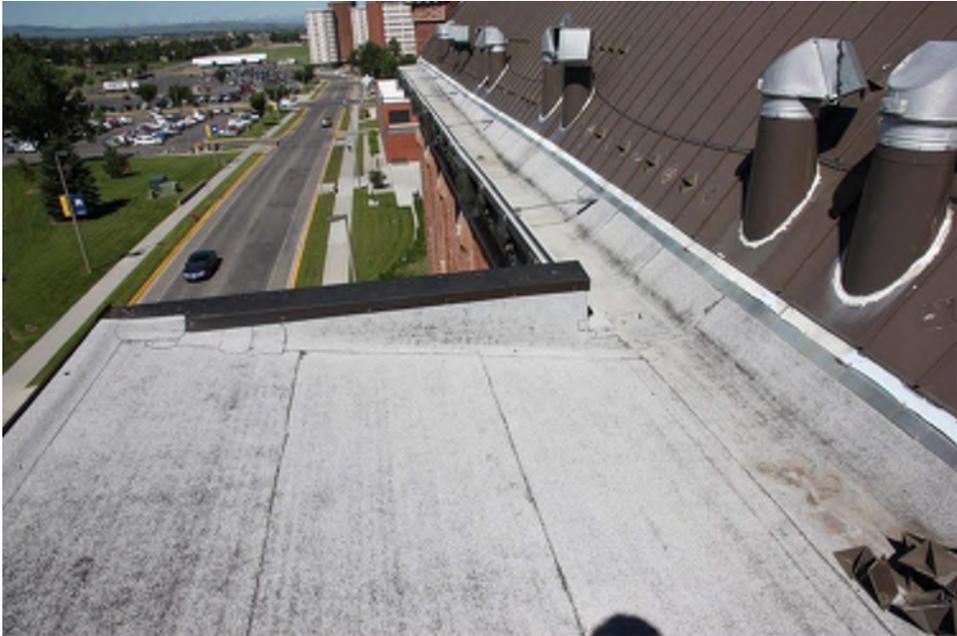
Figure 30: The flat roofing membrane extends over the parapet wall and is used to line the built-in gutter.

The flat membranes of the upper roofs appear to be in good condition. The seams are tight, the material is not heavily worn, and the aggregate cover appears sufficient.

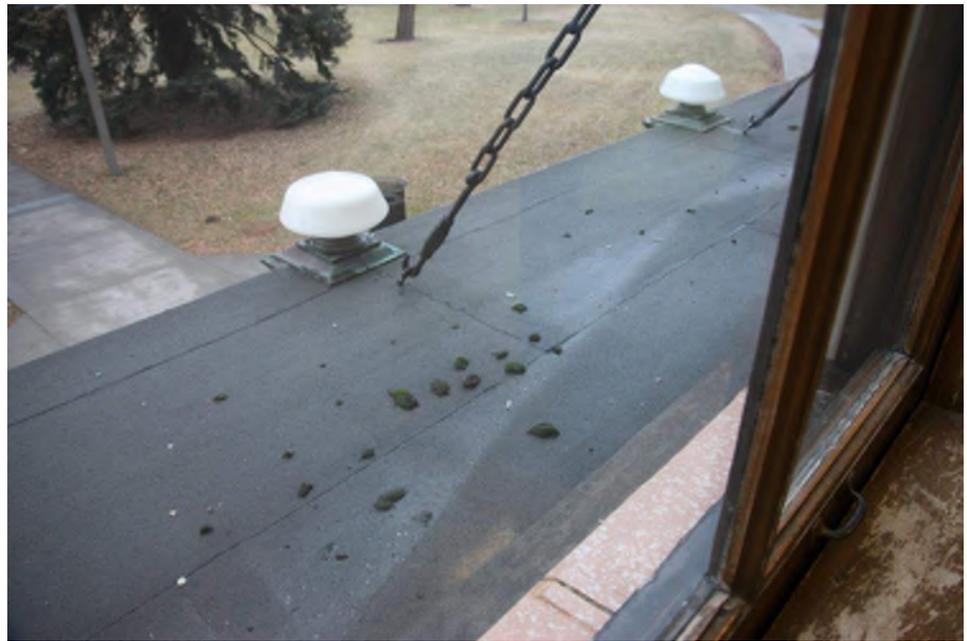
Figure 31: The flat membrane roofing over the marquee has mold growth and openings at the seams.

The seams of the flat membrane of the marquee roof appear to be opening up, with deterioration of the adhesive. Organic growth, in the form of moss clumps, is prevalent (as it is at this north face of the building) but not damaging.

The open seams should be resealed immediately. The roofing will probably outlive its usefulness within ten years and should be replaced at or before that time.

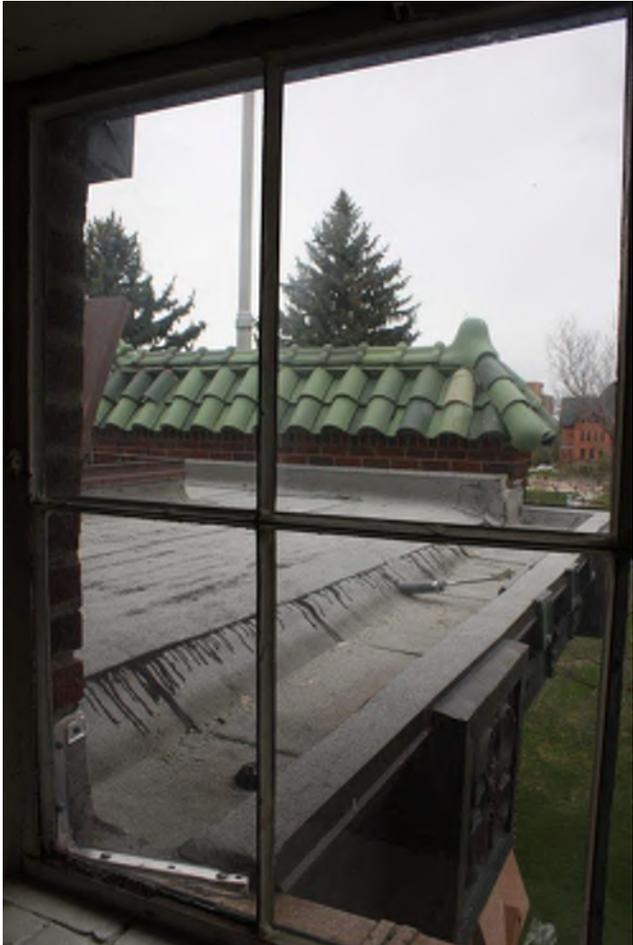
The gutters appear to adequately slope to the drains, yet the liners are worn and some of the seams appear to be open. The north downspout runs have minimal elbow extensions which could lead to excessive water build-up adjacent to the building's foundation.

Efflorescence and open mortar joints at the masonry walls below the gutters and scuppers

indicates that open joints in the gutter system

Figure 32: The north flat roof and built-in gutter east of the entry bay barrel roof.

are allowing moisture into some of the walls below.

In the short term, tighten and resecure all joints in the gutter liner, cornice, and scupper systems, sealing their skyward seams where able. This will require a close inspection of all joints and the detail where of the juncture between the gutter and the cornice. The gutter liners should be replaced within five years.

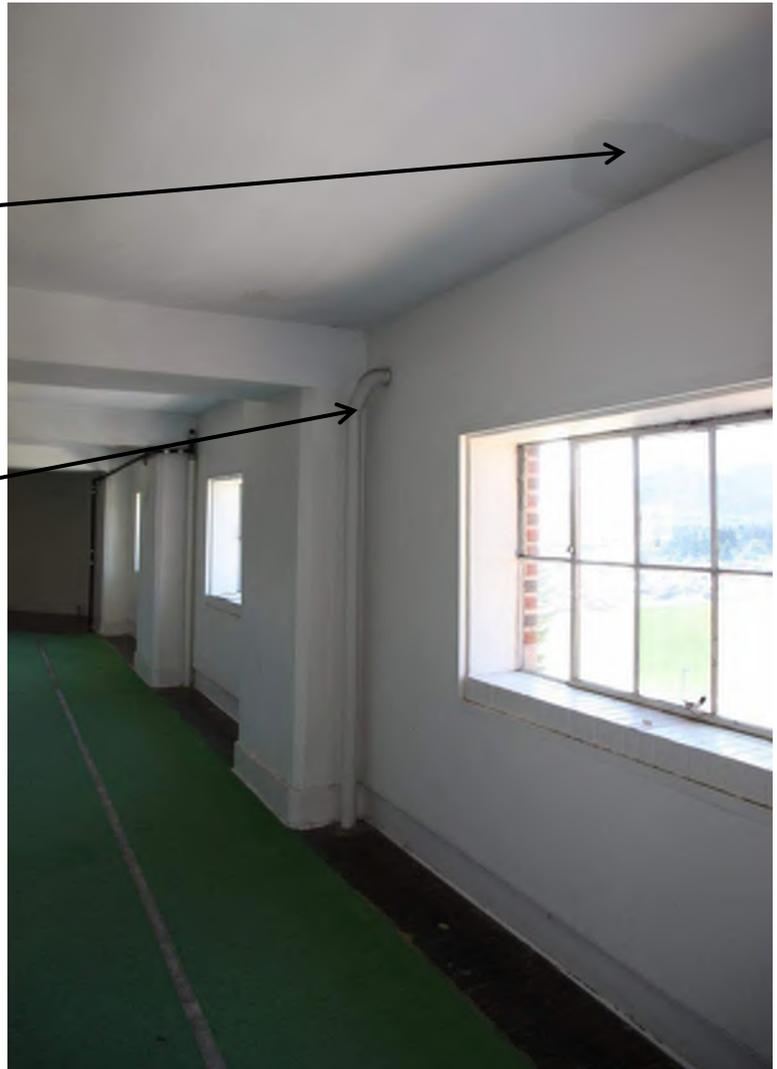
Painted copper downspout

Plaster patch at ceiling could be attributed to water damage from the gutter or from leaking joints at the roof vents (see Roof Penetrations below).

Figure 34: The copper downspouts are now run inside the building, and painted to blend with the wall.

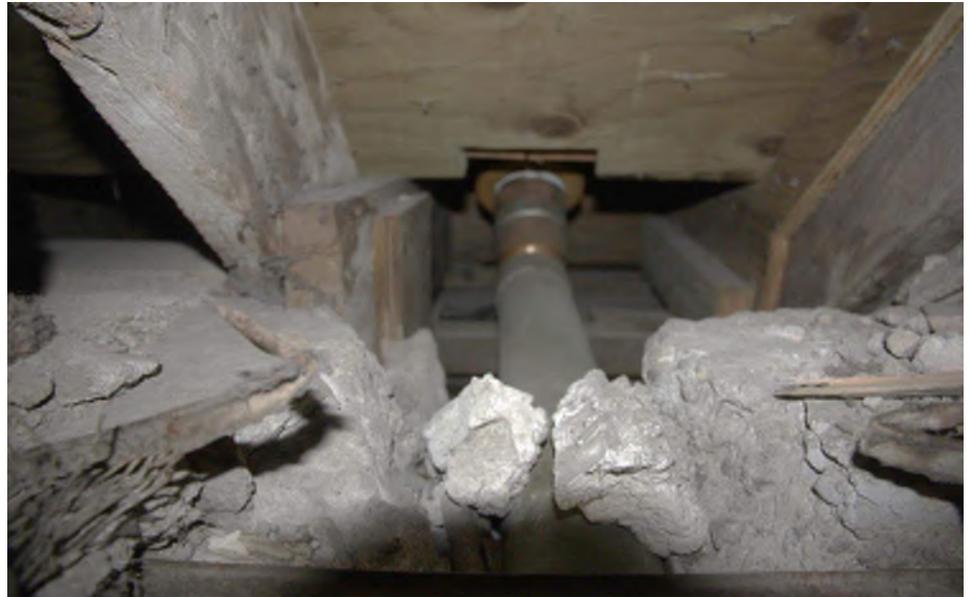
Figure 35: The copper downspouts are now directed into the warmth of the building. Drain and downspout at northwest corner of main barrel-vaulted roof.

Provide longer extensions at the north downspouts adjacent to the entry bay roof and the marquise roof.

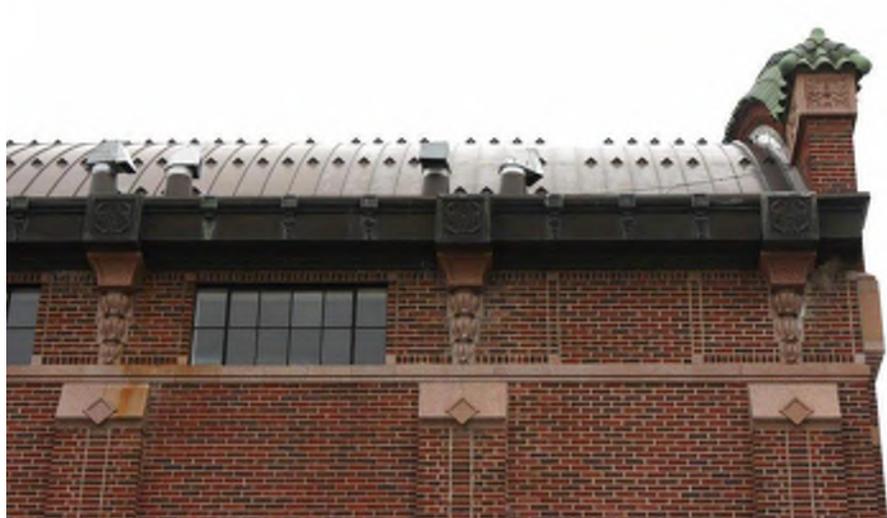
Figure 37: The paired ventilators flank the columns.

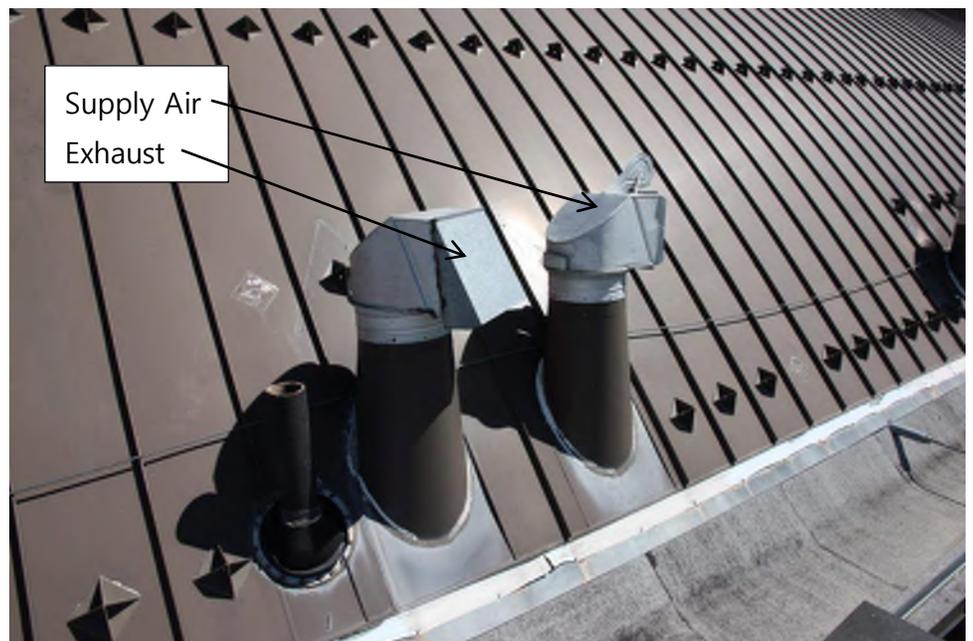
Figure 38: The paired ventilators are now of galvanized sheet metal.

It is presumed that the original ventilators were of copper; the current ventilators might have been installed during the 1985 reroofing project. Snow guards are (and were) located above each pair of ventilators.

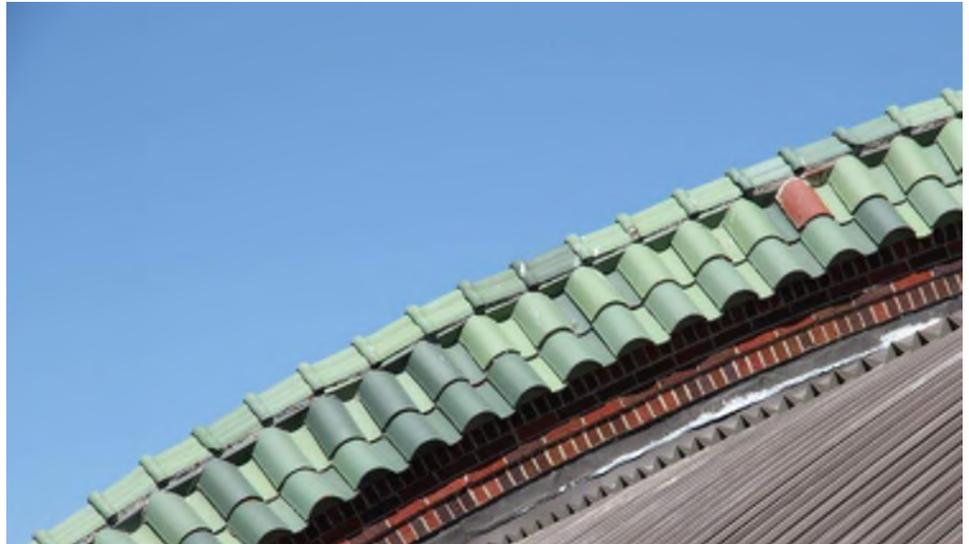
The tiles appear to be mortared securely in place. The good condition of the parapet walls below indicate that the tiles are providing sufficient protection.

Figure 41: Mission style clay tile covers the arched parapets. Roofside view of west parapet wall.

No work required.

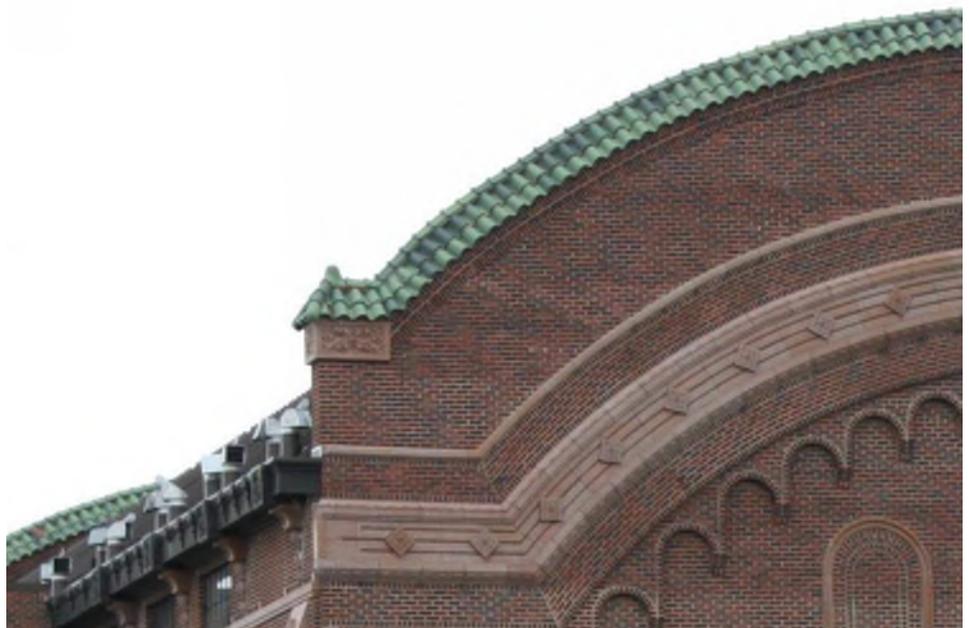
Figure 42: The ends of the parapet walls are pronounced with terminal bump tiles.

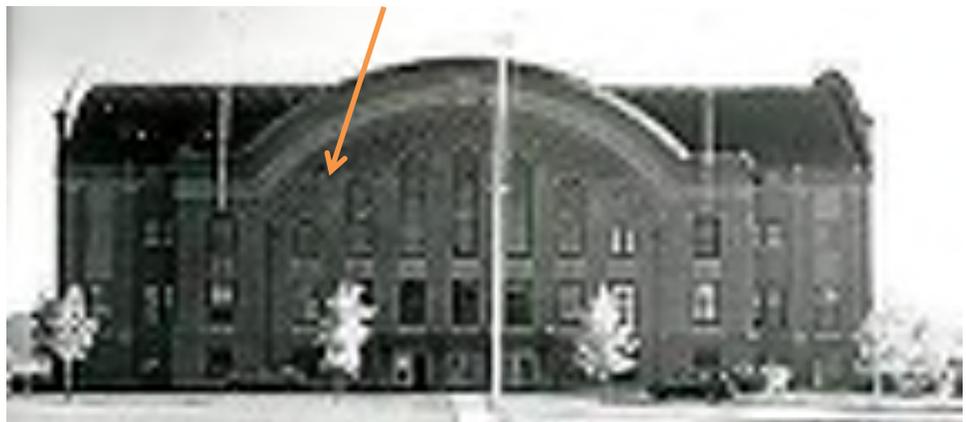
Figure 46: 1923 photograph of the north elevation, with distinct line of mortar color variation (see arrow point). Photograph courtesy of MSU Special Collections.

There appears to have been a pause in construction of the brick walls – perhaps for inclement weather – that is apparent in a clear distinction on all elevations just below the fourth floor windowsill level. See Figure 46 for early appearance of this marking.

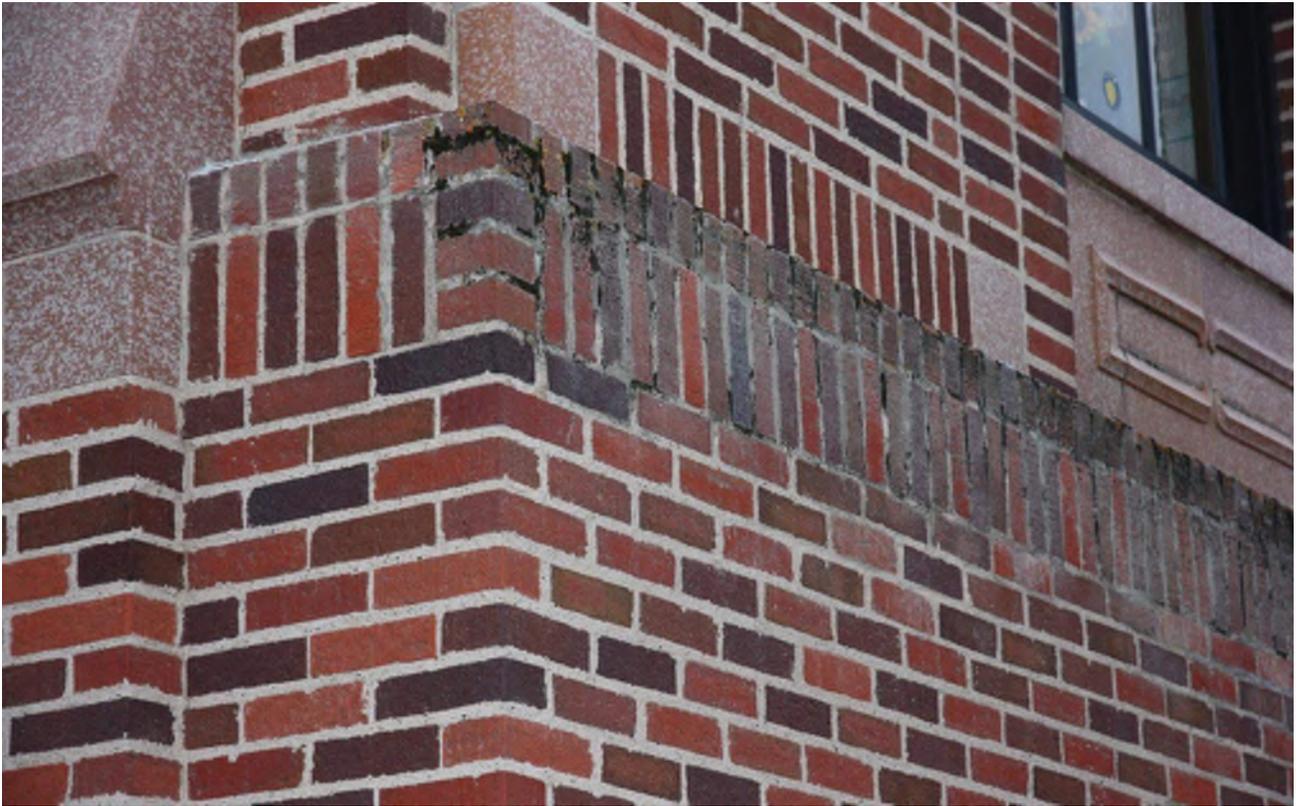
The north face of the building is subject to cooler, moister temperatures, as indicated by the substantial growth of moss and lichens on the horizontal masonry surfaces. Wall areas below the built-in gutters are subject to water – and resultant efflorescence – from leaks in gutter joints (see Roof Drainage & Collection above).

Figure 53: Moss accumulation at the beltcourse at the northwest side of the building.

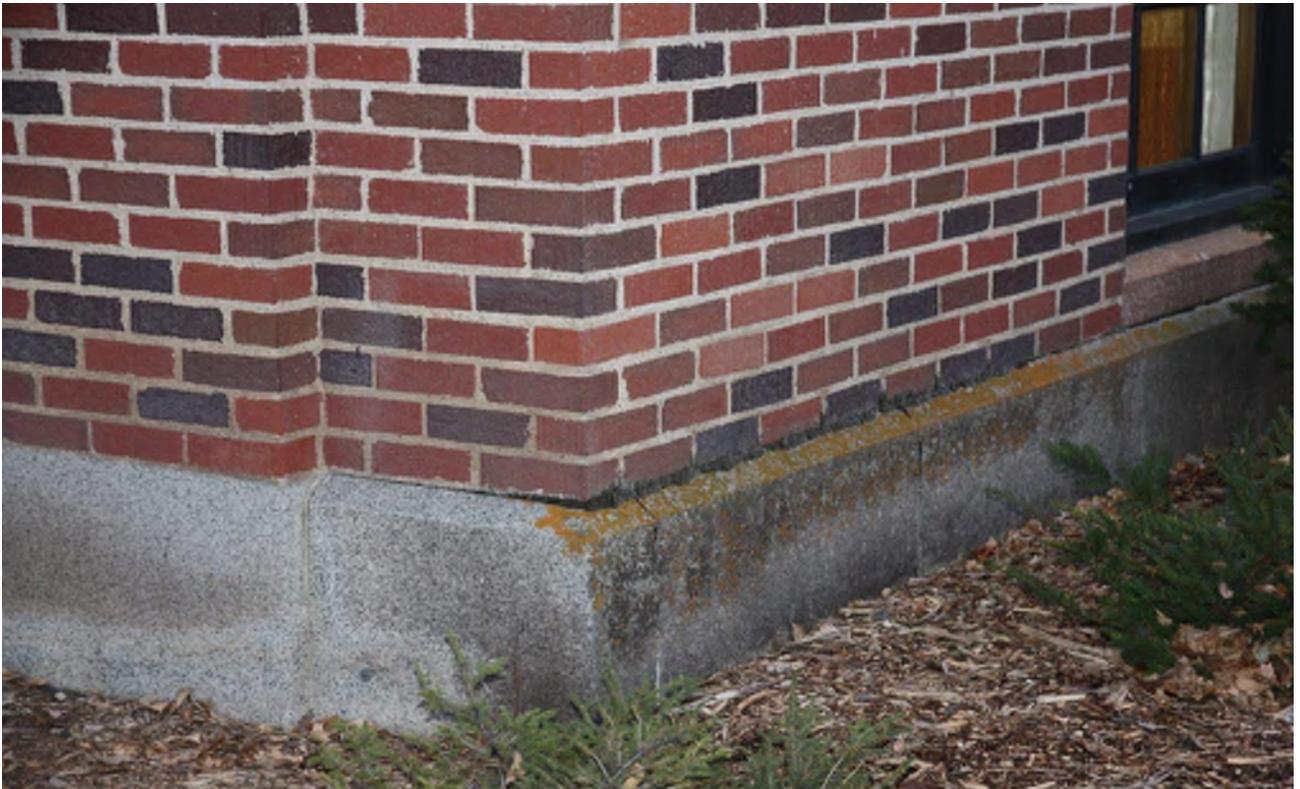
Figure 54: Lichen growth at the northwest side of the building, with moss at the top of the granite base.

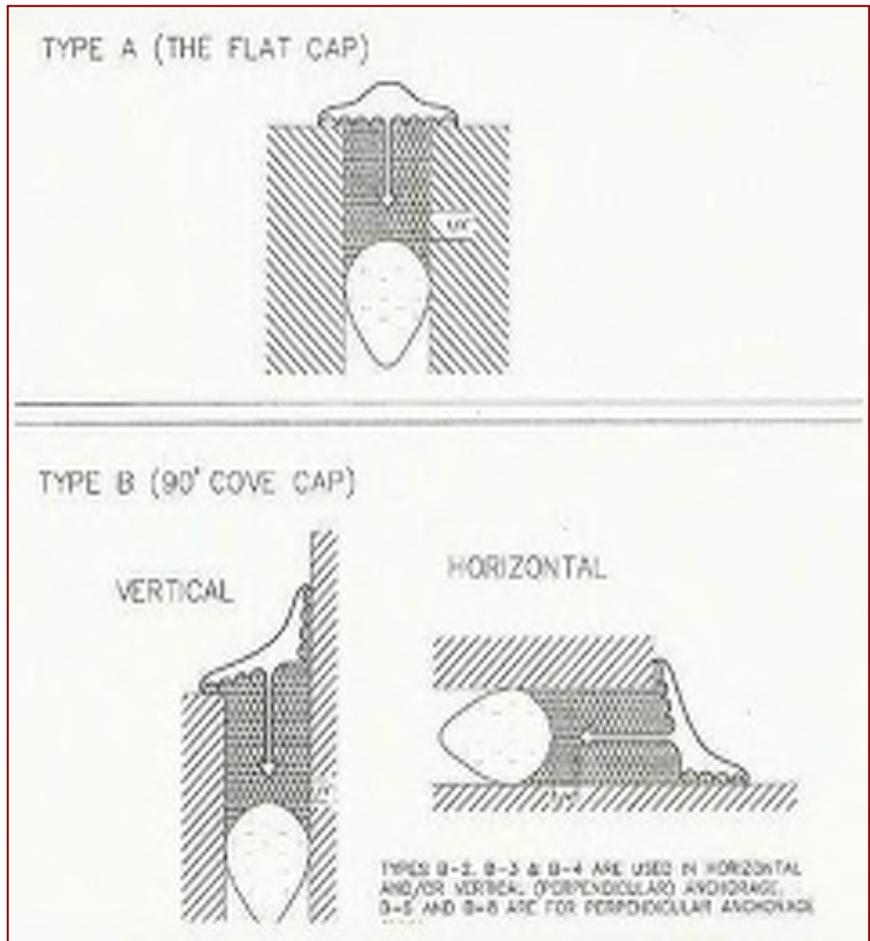
Figure 55: Weathercap can be used on existing joints as narrow as 1/4" and can be used at vertical wall joints.

should be provided with extra protection. The sloped wash should be removed and replaced with a lead caming system (Weathercap, for instance).

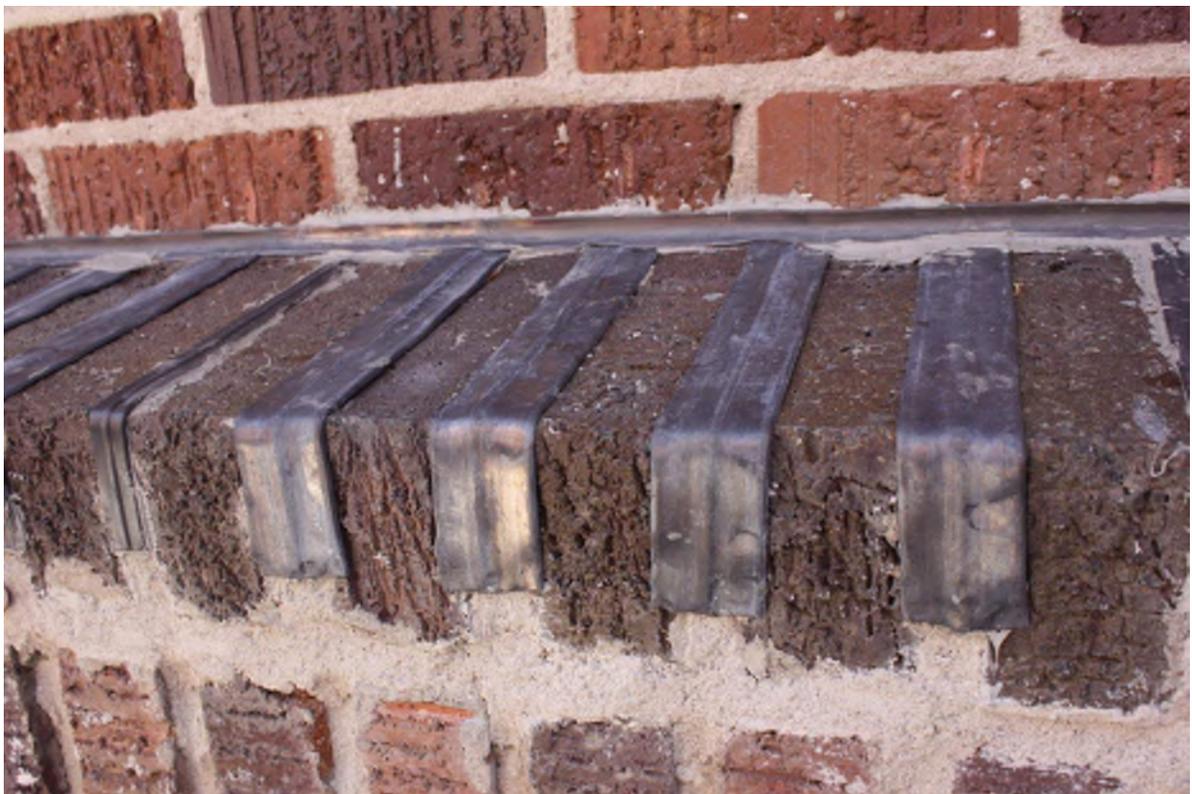
Figure 56: Example of Weathercap installation at similar beltcourse at Traphagen Hall, MSU campus.

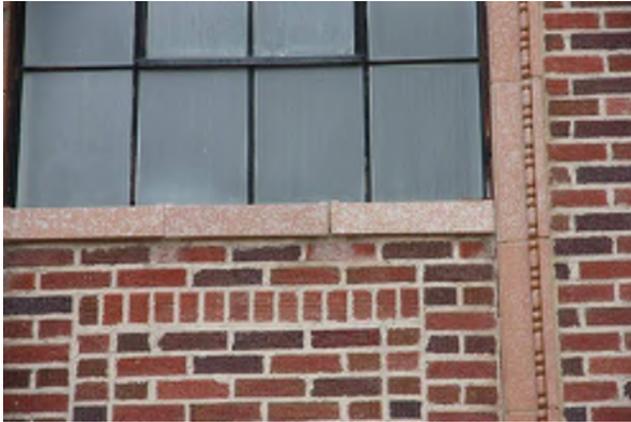
There is no spalling of the terra cotta – each unit is sound and appears to be well adhered to the wall structure. Many of the mortar joints of the arched and sill units are open. This has created open joints and staining in the brick below. As with the brick, there is mold growth on terra cotta units on the north façade. It appears that approximately 20-25% of the mortar joints are eroded.

Figure 61: A number of the sill joints are open, as is typical for vulnerable skyward joints.

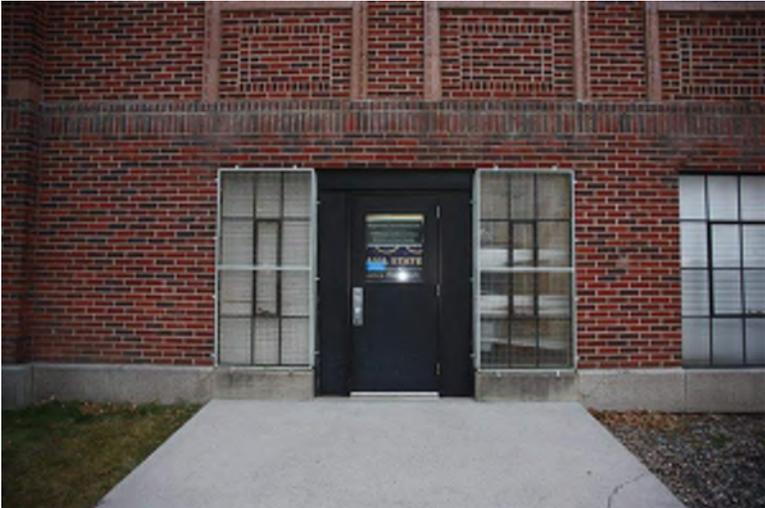
Figure 68: A hollow metal door has been inserted to provide grade level access to the Human Performance Lab at the west lower level of the building.

The doors are in serviceable condition and are wide enough to provide handicapped accessibility.

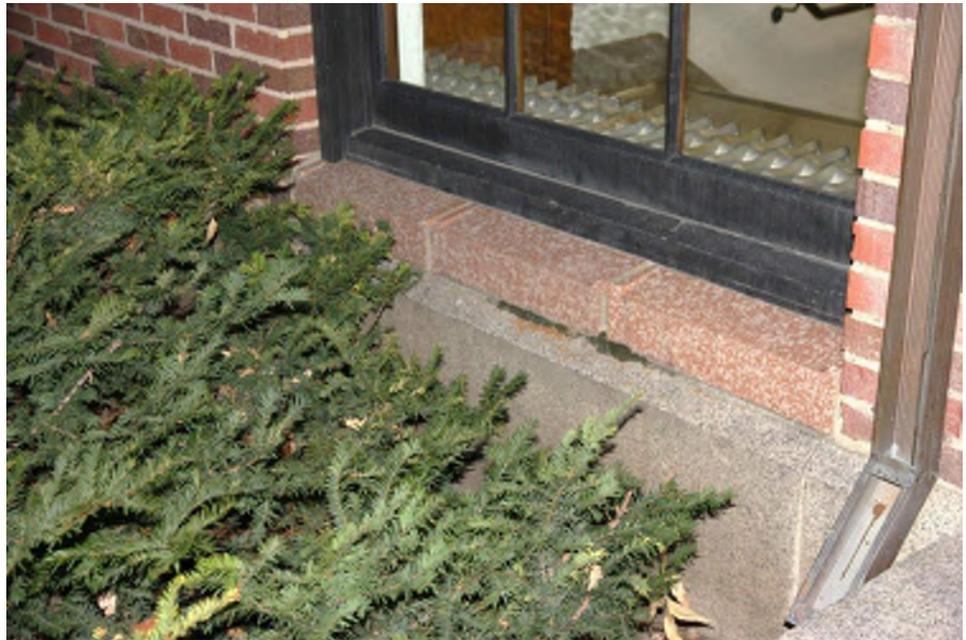
Figure 71: The exterior components of the wood windows are generally in excellent condition.

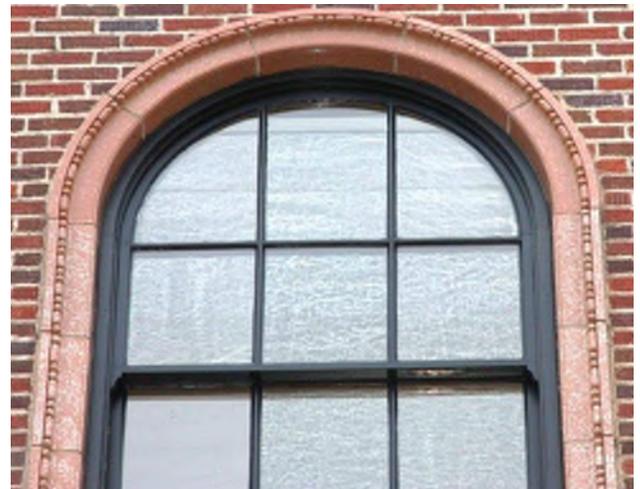
The interior wood stools are typically worn to bare wood, as they are typically subject to the steam heat generated by the radiators. The exterior wood sills and brickmolds are in excellent shape; some of the paint is worn. The paint at some of the bottom rails and stiles is worn, and some of the glazing putty is

Figure 72: The exterior components of the windows at the upper floors are in excellent condition.

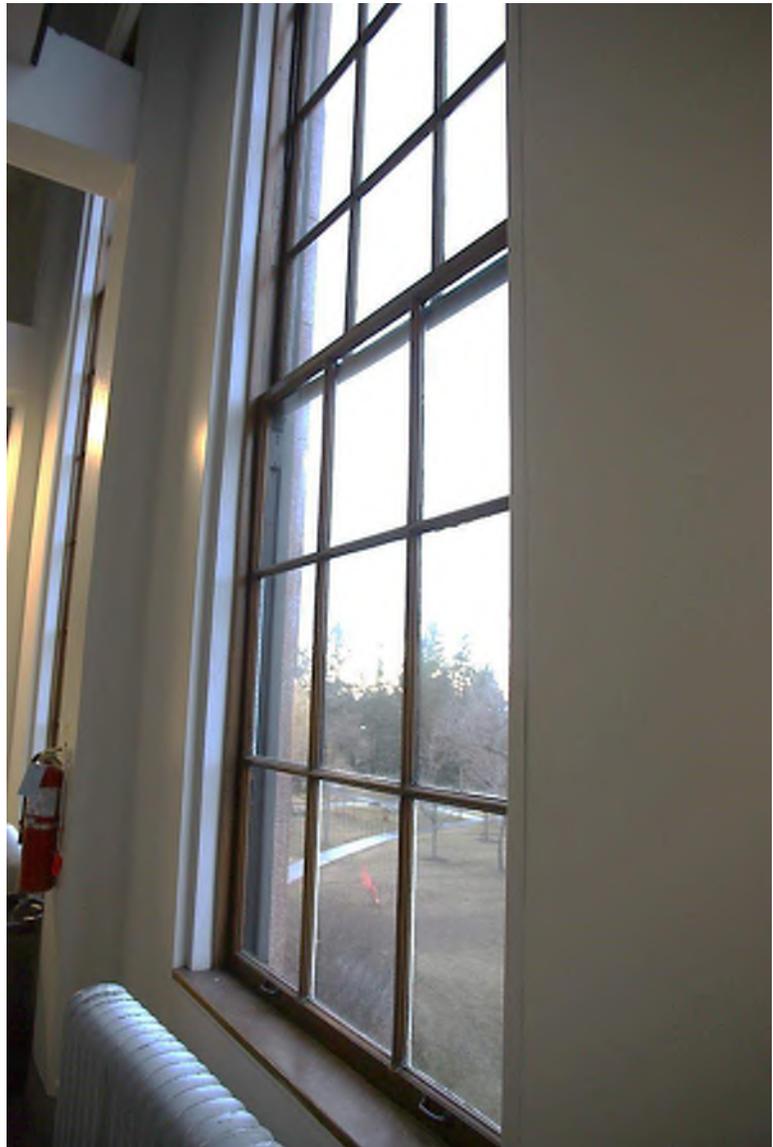
The tall third floor windows at the north wall of the entry stairway have bowed and deflected, responding to their unsupported height of 16'-20'. Gaps between the meeting rails contribute to air leakage.

Figure 73: A gap at the meeting rail of the two-story window of the north stair hall.

The tall windows at the north entry wall need to be treated as above and stabilized to prevent air gaps. Consideration should be given to rendering the tallest units inoperable.

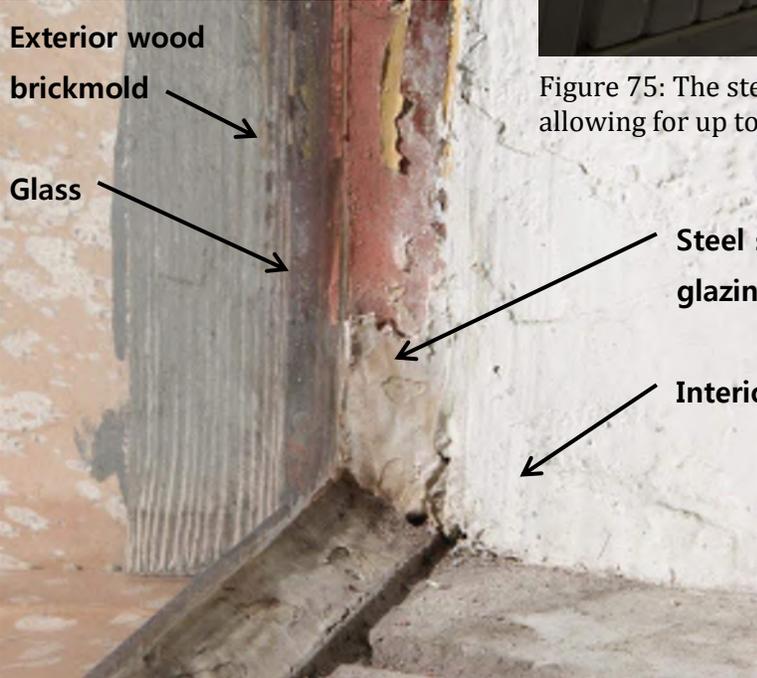
Steel sash and glazing putty

The sash are generally sound and operable. The glazing putty is generally sound, yet much of the paint cover is worn. The windows are stable, yet much of the paint finish is worn and interior steel has surface rust in the Locker Rooms. Some of the chains and hardware parts are missing.

Figure 76: The steel sash are set directly into the window jamb. The putty and paint are worn.

Sandblast and repaint all steel members. Replace all glazing putty. Provide replica pieces for missing hardware and lubricate existing hardware. Repaint steel.

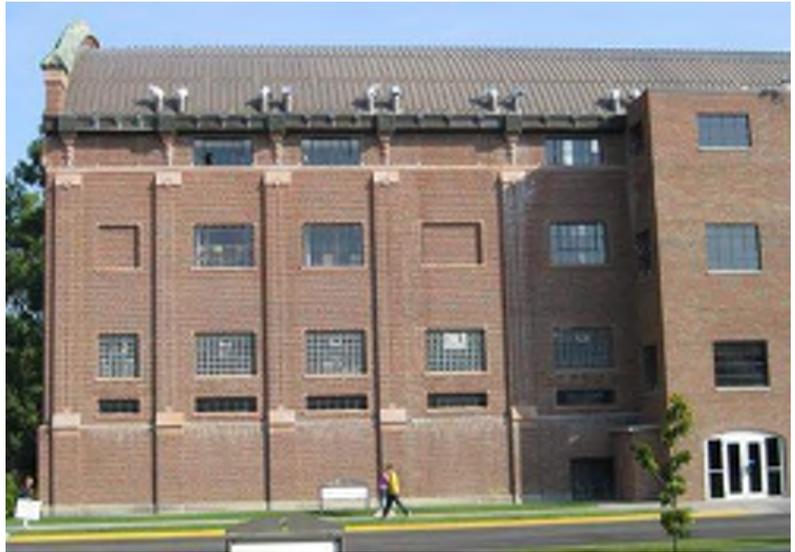
The glass block is in good condition.

Figure 79: The large Pool Room window openings have been filled in with glass block.

Remove the glass block and install new steel sash, with insulated glass, in a configuration to match the original (as determined by historic photographs, size, and original construction drawings).

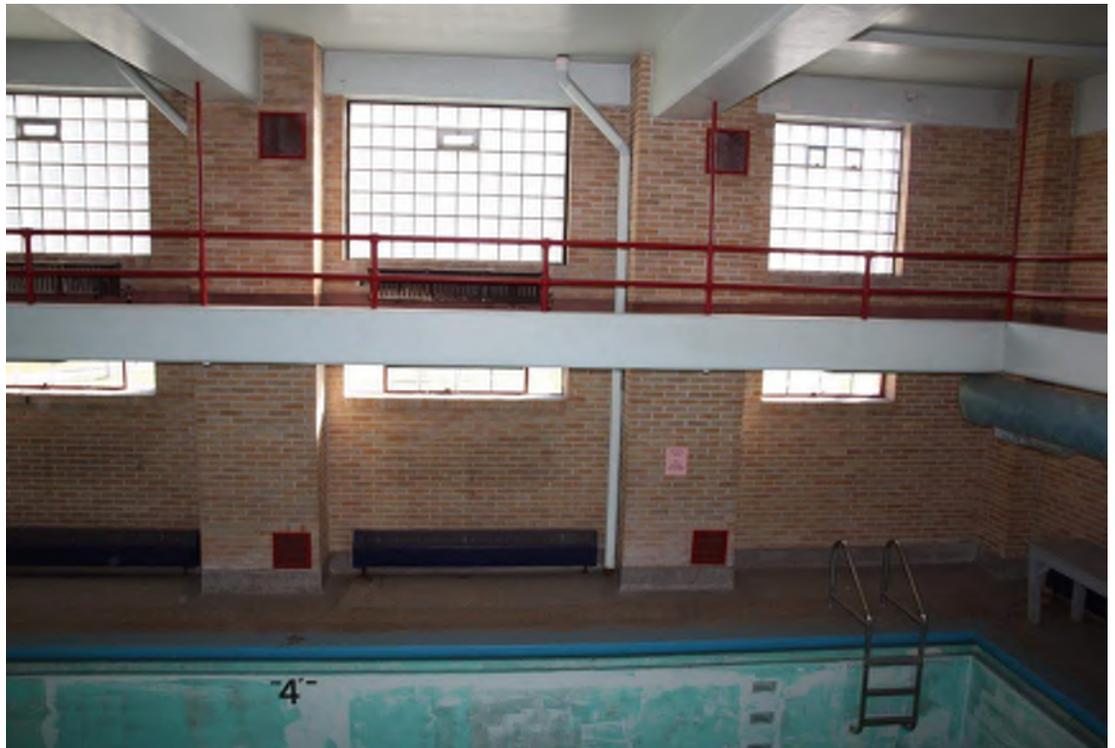
Figure 80: Glass block window openings in the Pool Room; the original steel sash (1 pane high) remain below.

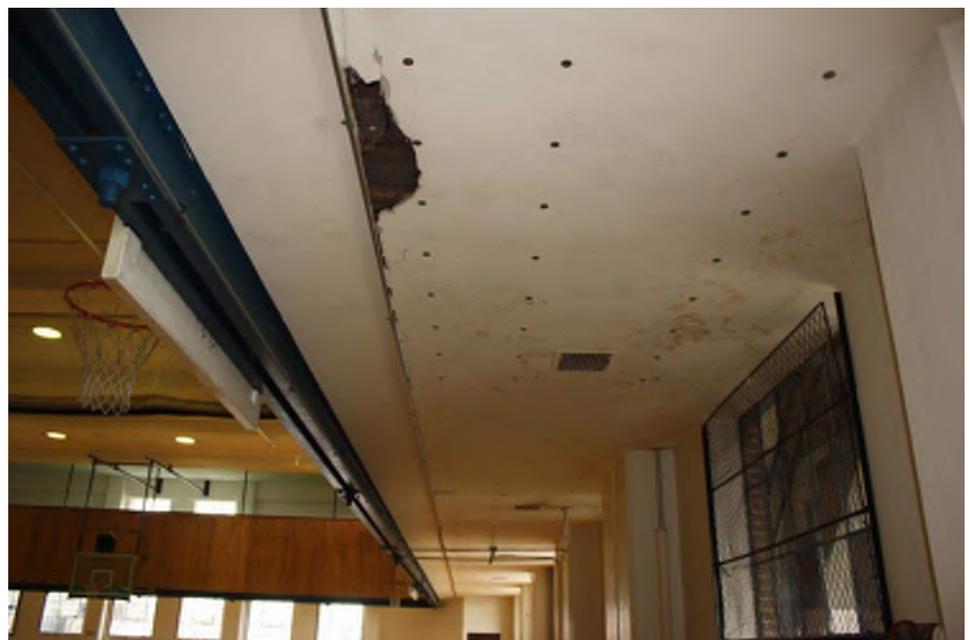
Figure 82: The original steel support structure is visible at the underside of the existing balcony. Plaster washers have been used to resecure the plaster soffit.

5. Much of the plaster at the soffit below the Main Gymnasium balcony has been delaminating; plaster washers have been used to readhere the plaster. This condition is probably caused by live loads and impact on the balcony above.

Patch and repair plaster after root cause has been addressed.

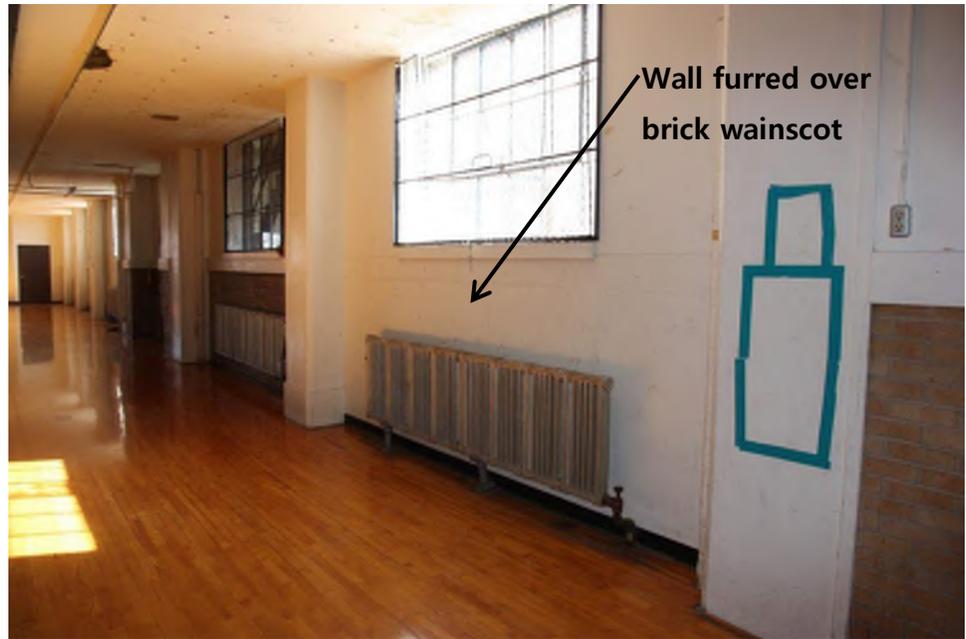
Figure 86: Some of the brick wainscot in the Main Gym has been concealed with a furred wall finished with gypsum board.

Some of the brick walls have been concealed with furring finished with gypsum board, and some of the rowlock sills have been painted. Where visible, the brick and mortar joints are in good condition.

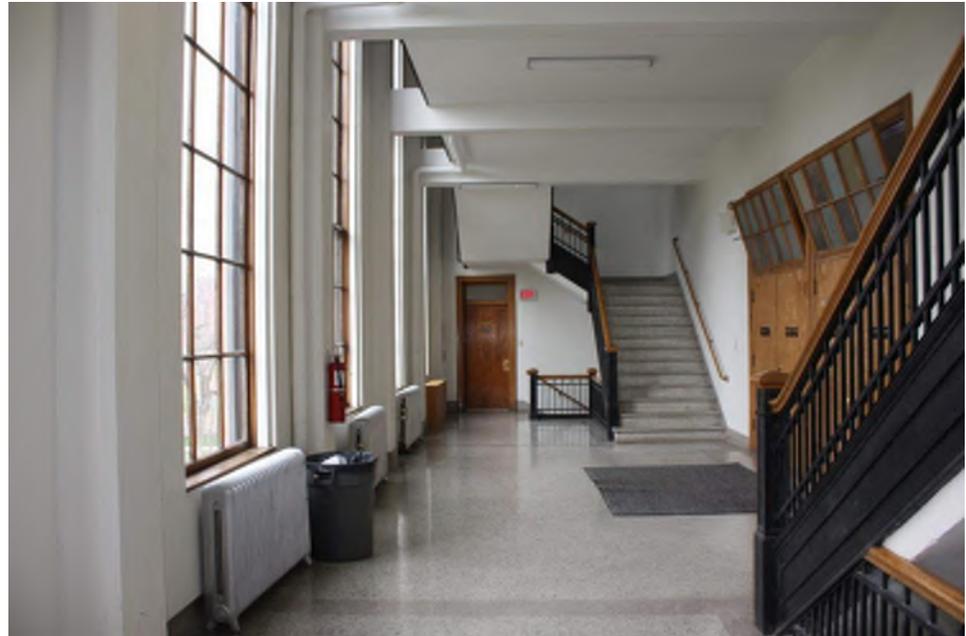
The stairs and handrails are generally in excellent condition. One of the terrazzo nosings in the north stair run is abraded from impact.

The handrails and guardrails at the front stairway are not compliant with accessibility standards or code; they are not high enough and don't have extensions.

Figure 89: The front main stair hall risers, treads, and flooring are finished with durable terrazzo.

No work required. The handrails and guardrails can be retained as existing conditions per the International Existing Building Code and the Americans with Disabilities Act (ADA).

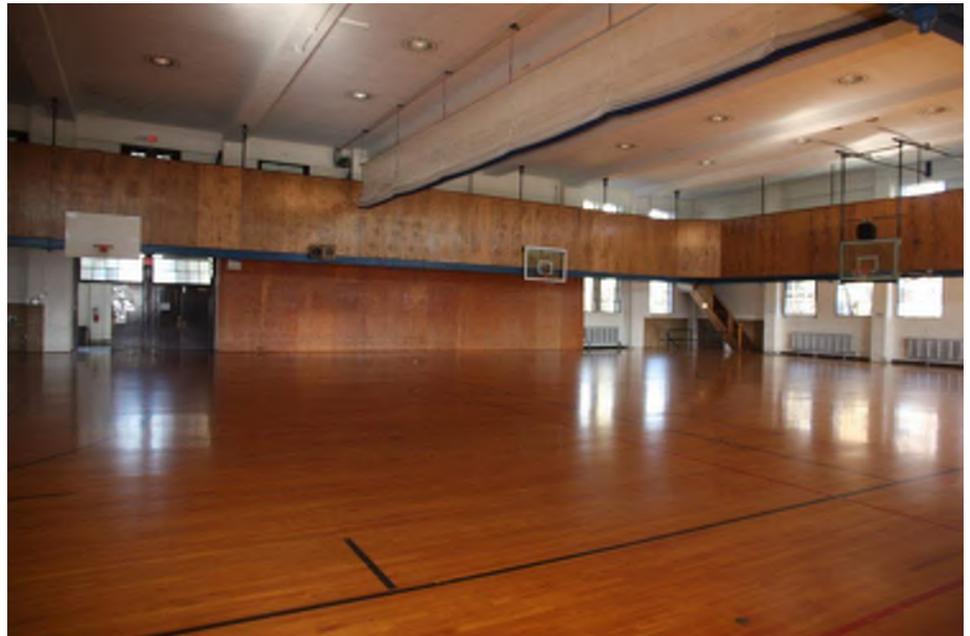
The maple flooring and finish is in very good condition, with only minor water staining. Streetshoes are not allowed on the floor, to prevent damage to the finish.

Figure 90: The original hard maple flooring in the Main Gym has been well maintained, thus continues to be durable.

Continue current treatment and maintenance of the wood flooring.

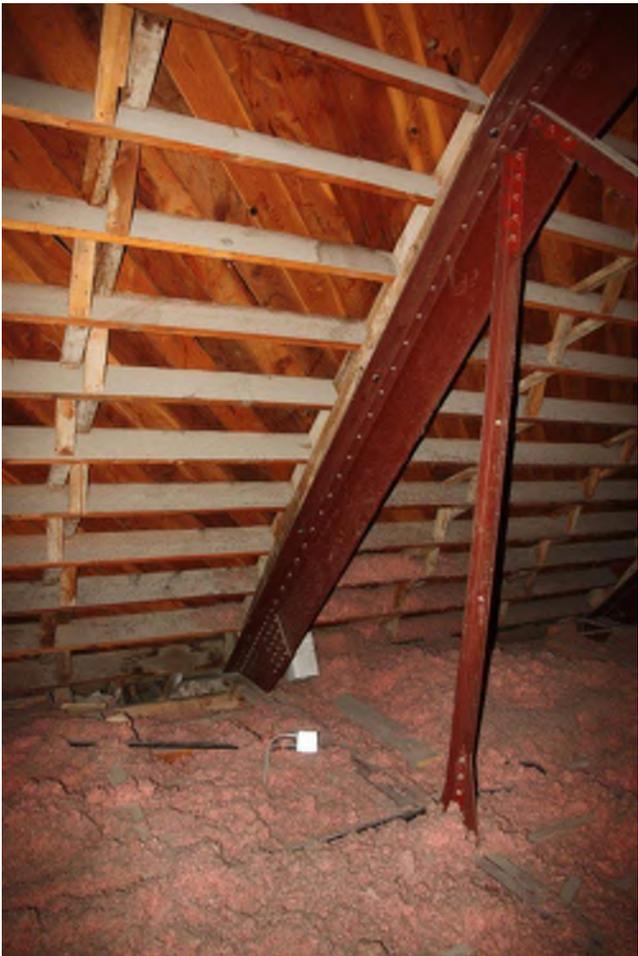
The board sheathing in the majority of the building appears to be intact. Some areas of staining from previous roof leaks are evident. Patchwork of the sheathing, is evident in some locations near the eaves. Some of the patched areas are at abandoned vent piping locations. The roof joists looked to be in good condition. Some occasional splits and cracks are observed but in less than one percent of the joists. A preliminary strength evaluation indicates that the joists are capable of carrying the intended roofing material loads

Figure 92: Diagonally-oriented board sheathing is visible above the joists. Note the regularly spaced bridging to the left and right of the steel truss and the loose-fill insulation at the floor level.

Limited, random joist replacement is required as necessary.

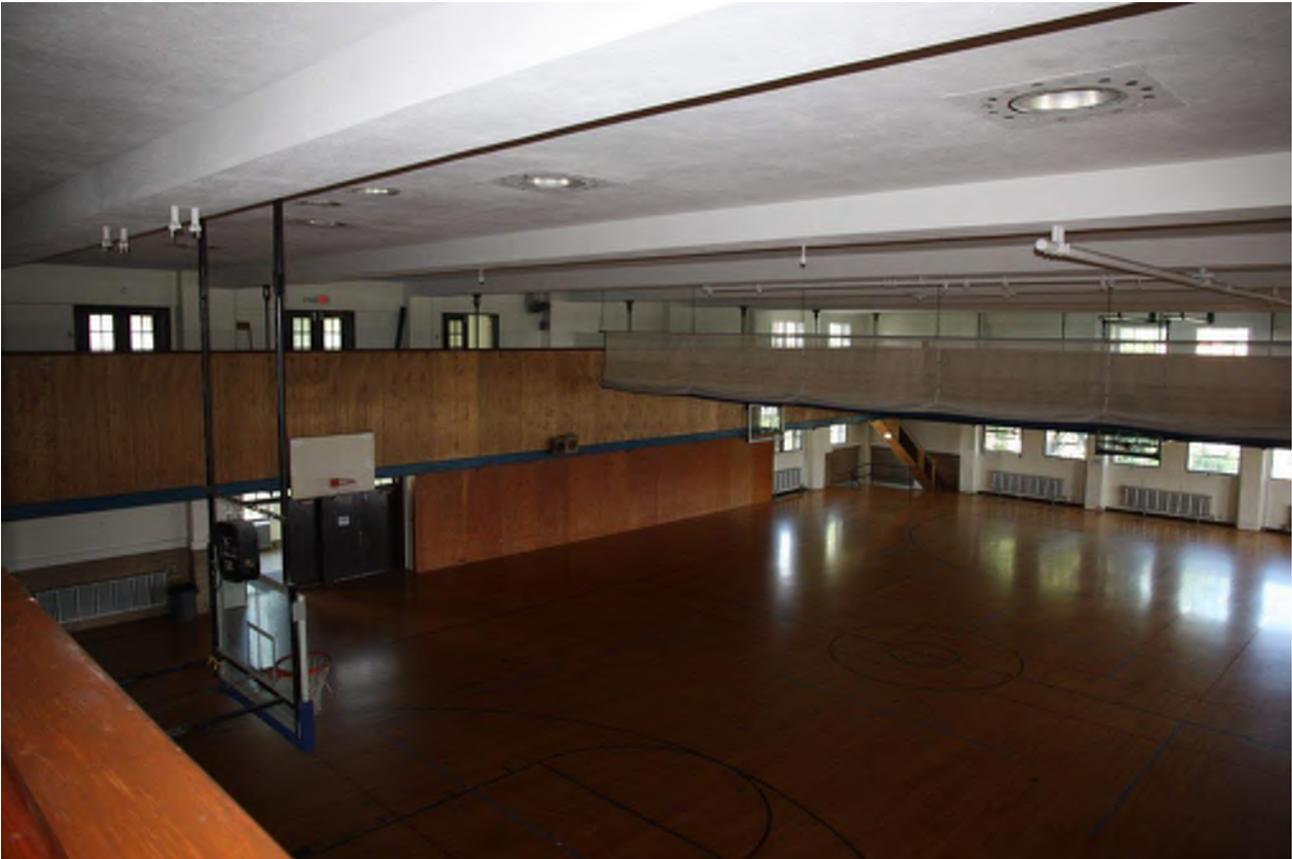
The joists appear to be in good shape. Some cracking or splitting is likely present in a few of the members. The insulating materials covered most of the joists; therefore total

Figure 93: The ceiling of the Main Gymnasium appears to be well supported structurally.

conditions could not be verified. A preliminary analysis indicates the joists have the capacity to carry the intended ceiling loads and minor maintenance foot traffic.

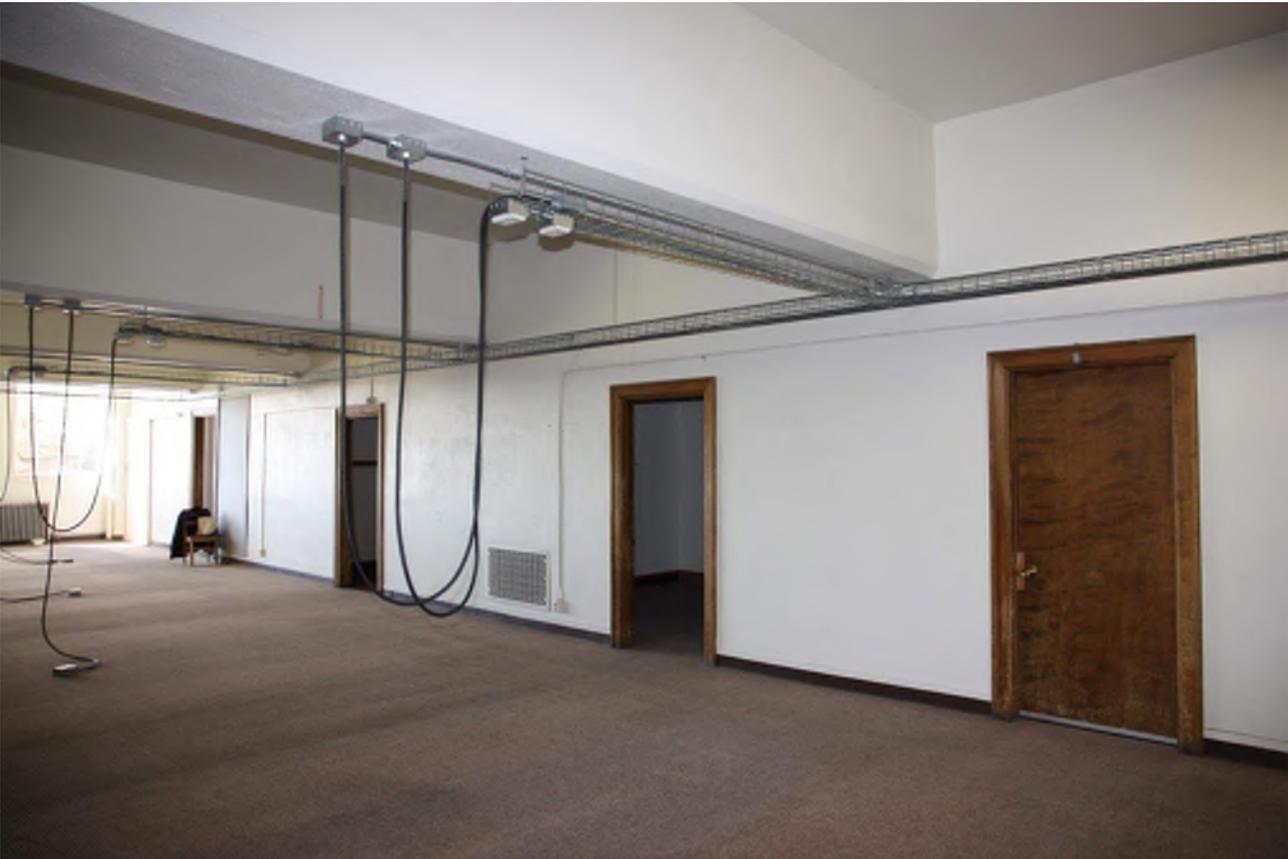
Figure 94: Large cast concrete Tee-beams support the third floor above this second floor room at the west side of the building.
