REQUEST FOR QUALIFICATIONS
GENERAL CONTRACTOR /
CONSTRUCTION MANAGER SERVICES

ROMNEY HALL RENOVATION
MONTANA STATE UNIVERSITY
Bozeman, MT

A/E #2012-02-14; MSU PPA #16-0164

NOVEMBER 2016

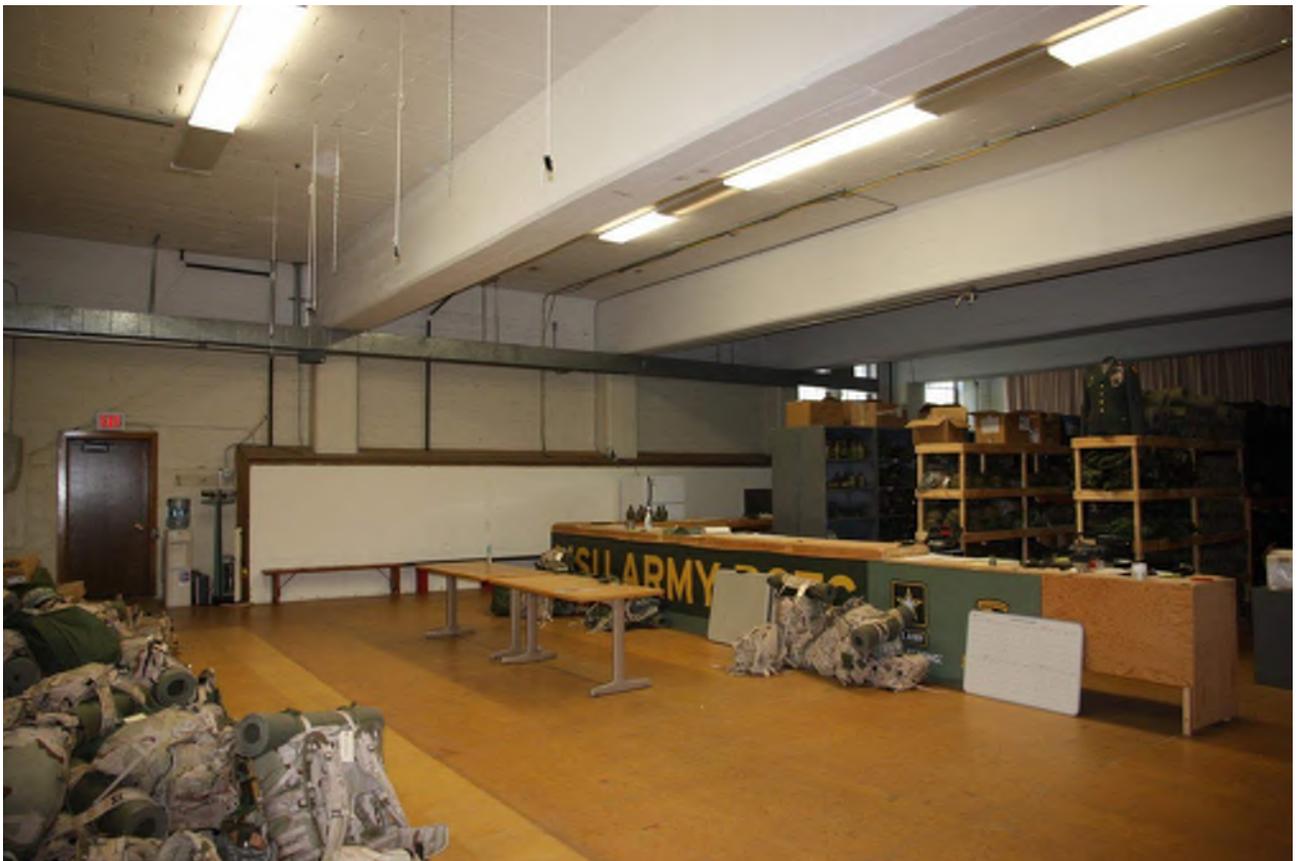
Figure 95: Deep cast concrete Tee-beams support the second floor (erstwhile locker rooms) above.

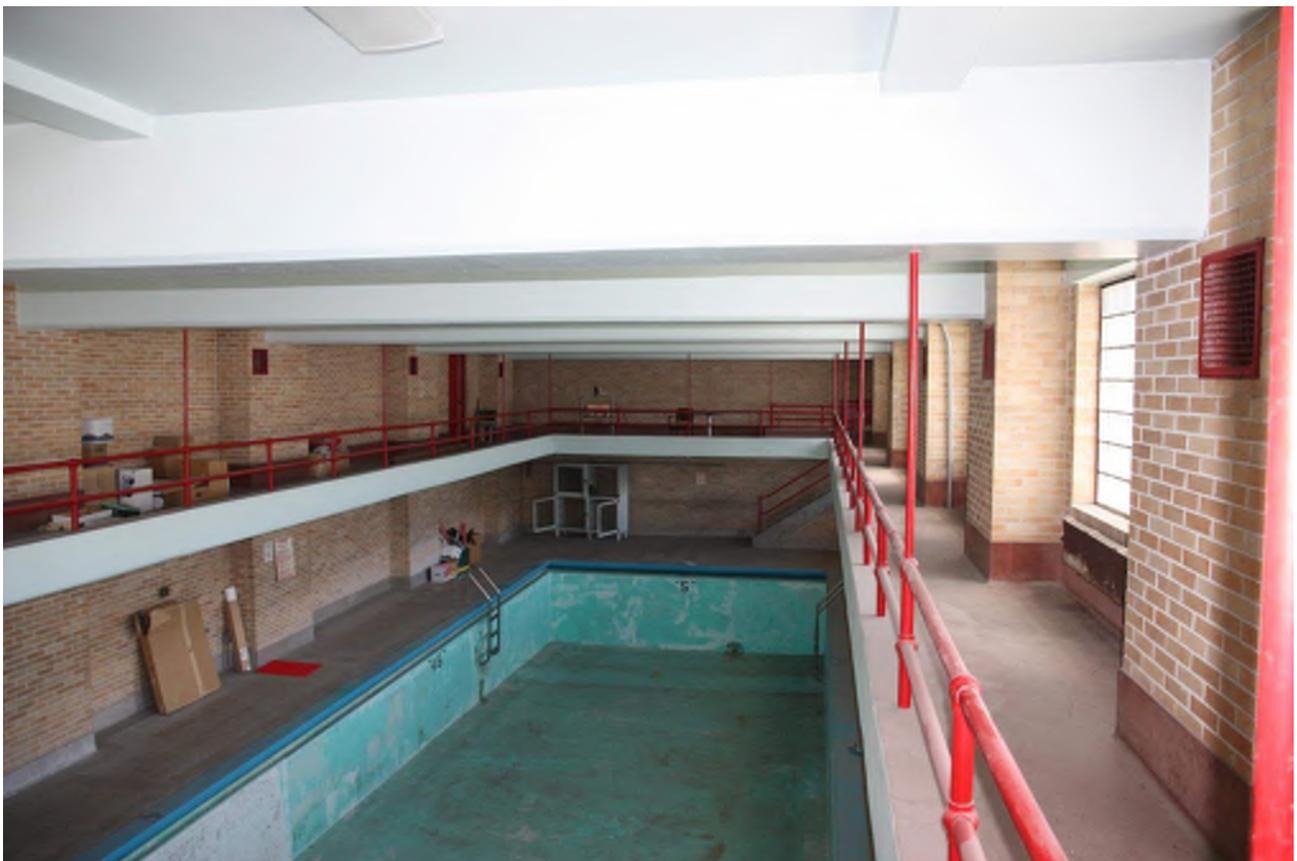
The suspended pool balcony appears to be in good shape; no deterioration is evident. The pool appears to have settled perhaps an inch or two. This has taken the surrounding concrete pool deck with it. The stairs and miscellaneous masonry elements either supported by the deck or in contact with the deck have stress cracks related to the movement. This does not pose a hazard but is unsightly.

Figure 96: The pool balcony is suspended from steel rods tied to the Tee-beams at the ceiling.

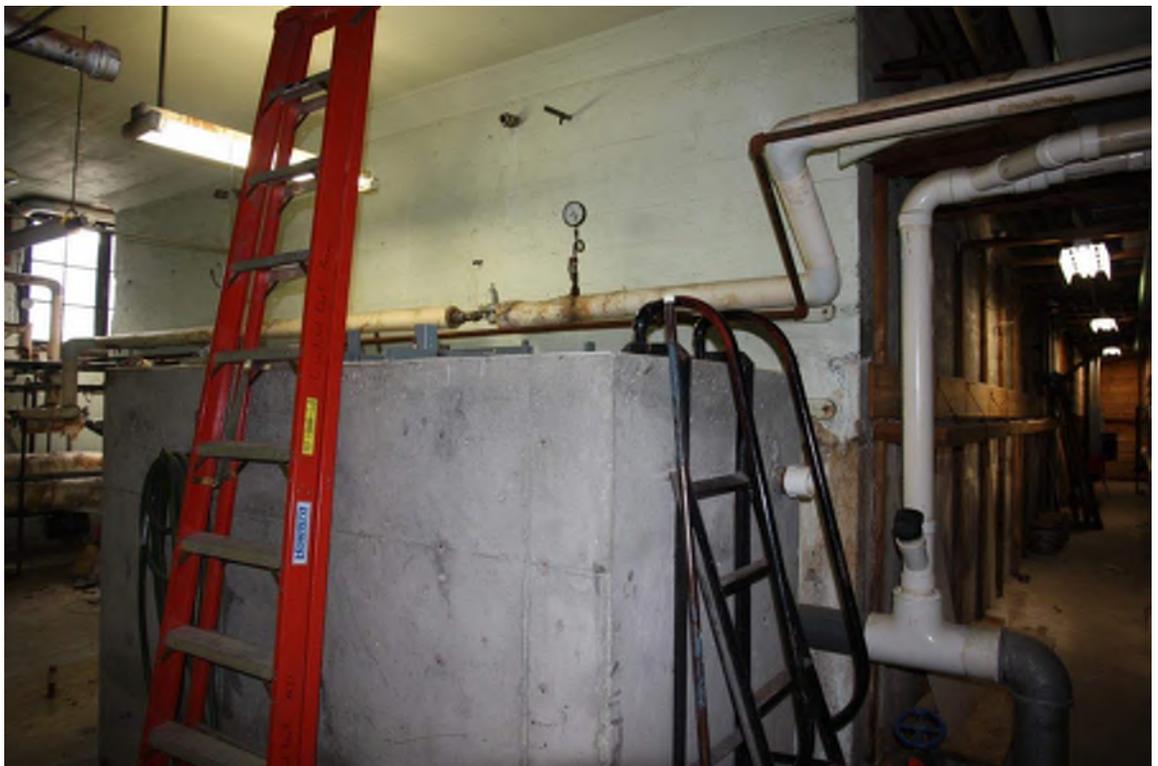
Figure 98: The pool basin is supported by cast-in-place concrete walls, visible in the lower level space below. The chlorine tank is in the foreground.

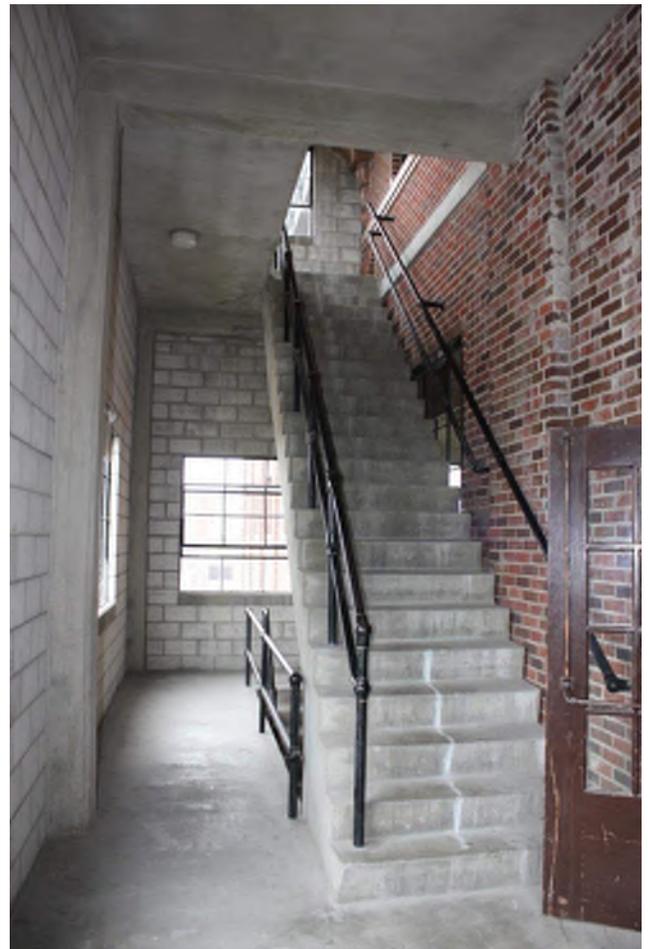
Figure 99: The south stairway is of exposed concrete structure. The walls were infilled c. 1945.

In general, the stairs and beams appear to be in good shape; no significant cracking in the elements can be found.

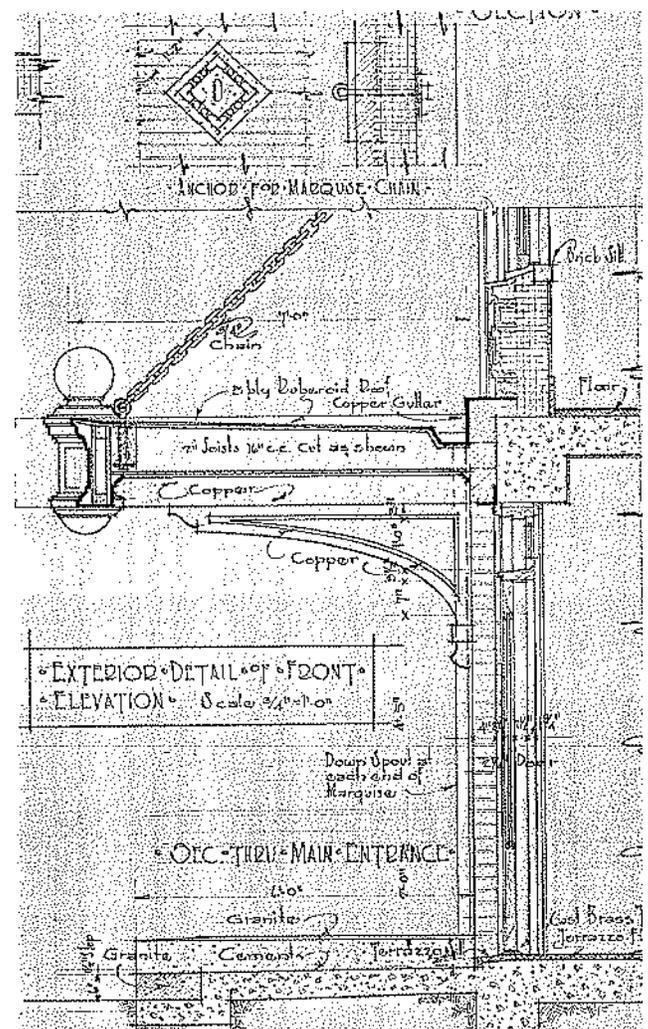
The covered roof over the north entry is depicted to be a wood framed structure supported by steel chains anchored to a concrete column or beam line in the exterior wall. The concrete exterior plaza is depicted to be resting on ten-inch thick concrete grade beams.

Figure 100: Marquis section from Sheet 11 of the 1921 construction drawings.

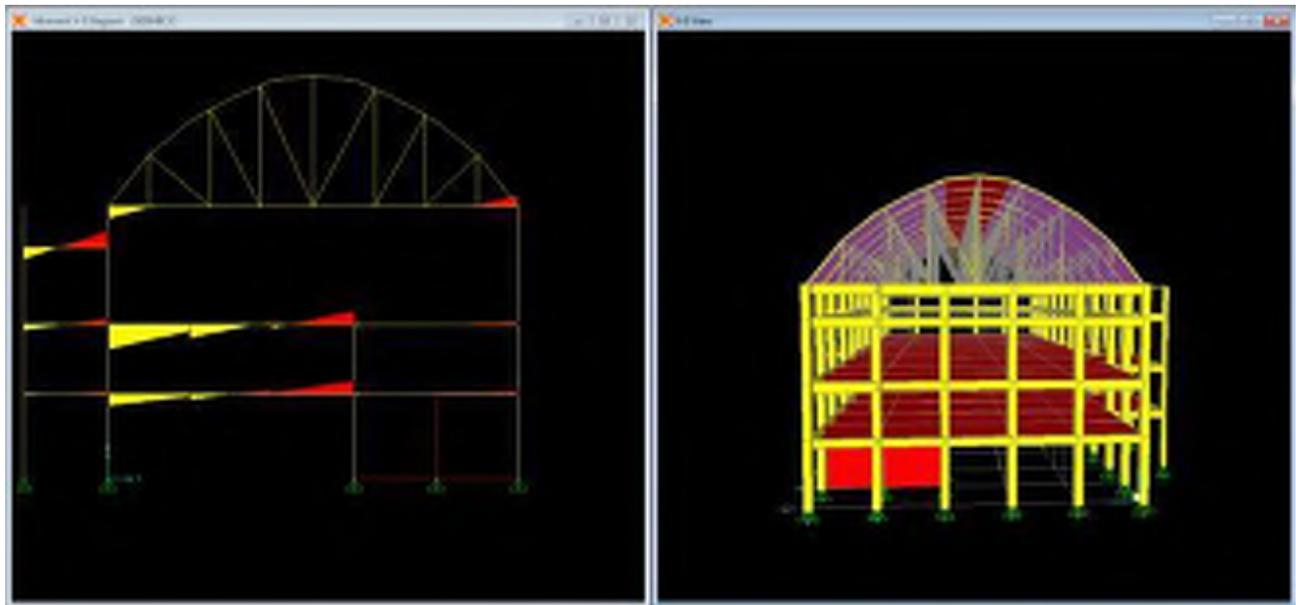
that would be deemed to perform acceptably in a seismic event. Despite the acceptable ratios of the majority of walls areas of cracking and small collapse are possible.

a ratio that would indicate very poor performance. As well, the clay tile wall separating the Main Gymnasium from the Auxiliary Gymnasium is thin and tall and might perform poorly. The fourth floor balcony in this case may provide some relief in the form of bracing the wall, in effect reducing its height; however, further

Figure 102: Code-Prescribed Shearing Forces Depicted in the Concrete Frames oriented south-to-north.

It is recommended that a detailed seismic analysis be performed in conjunction with future adaptive reuse plans incorporating the following elements:

- 1. Provide shear walls to accommodate the historical qualities of the building, either perforated or not, in locations suitable to the adaptive reuse of the building.
- 2. Install a suitable diaphragm slightly above a plane of the current Main Gymnasium ceiling. The wood

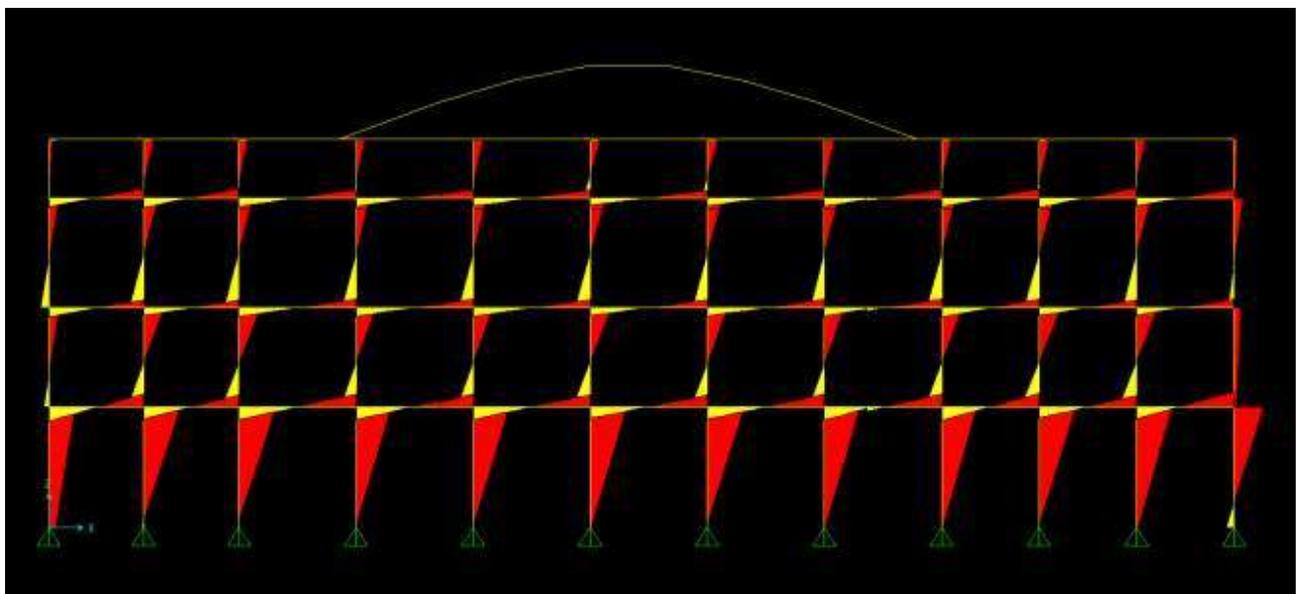
Figure 103: Code-Prescribed Moment Forces Depicted in the Concrete Frame oriented east-west.

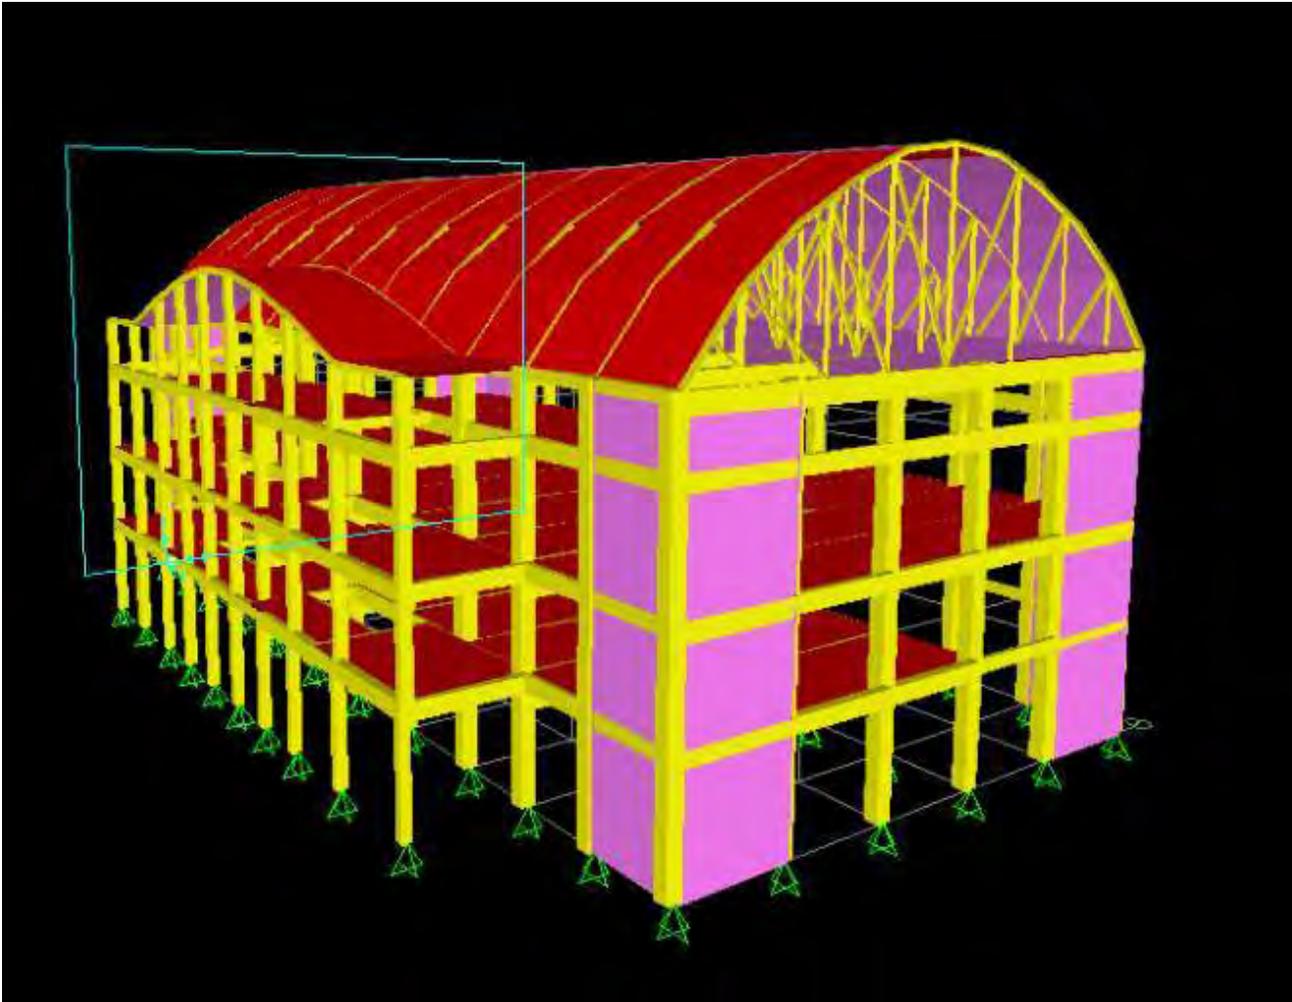
Figure 104: One option of Shear Walls Constructed in the Building's Corners (depicted in purple).

diaphragm does not have the capacity needed for this application. A steel horizontal braced diaphragm or a steel frame supported steel deck diaphragm would have the capacity to accommodate the seismic loading. This would mean that the wood supported ceiling of the third floor areas would need to be removed and replaced. A braced configuration following the form of the vaulted roof may have a small chance of working, however careful consideration of the additional seismic stresses imposed on the existing steel

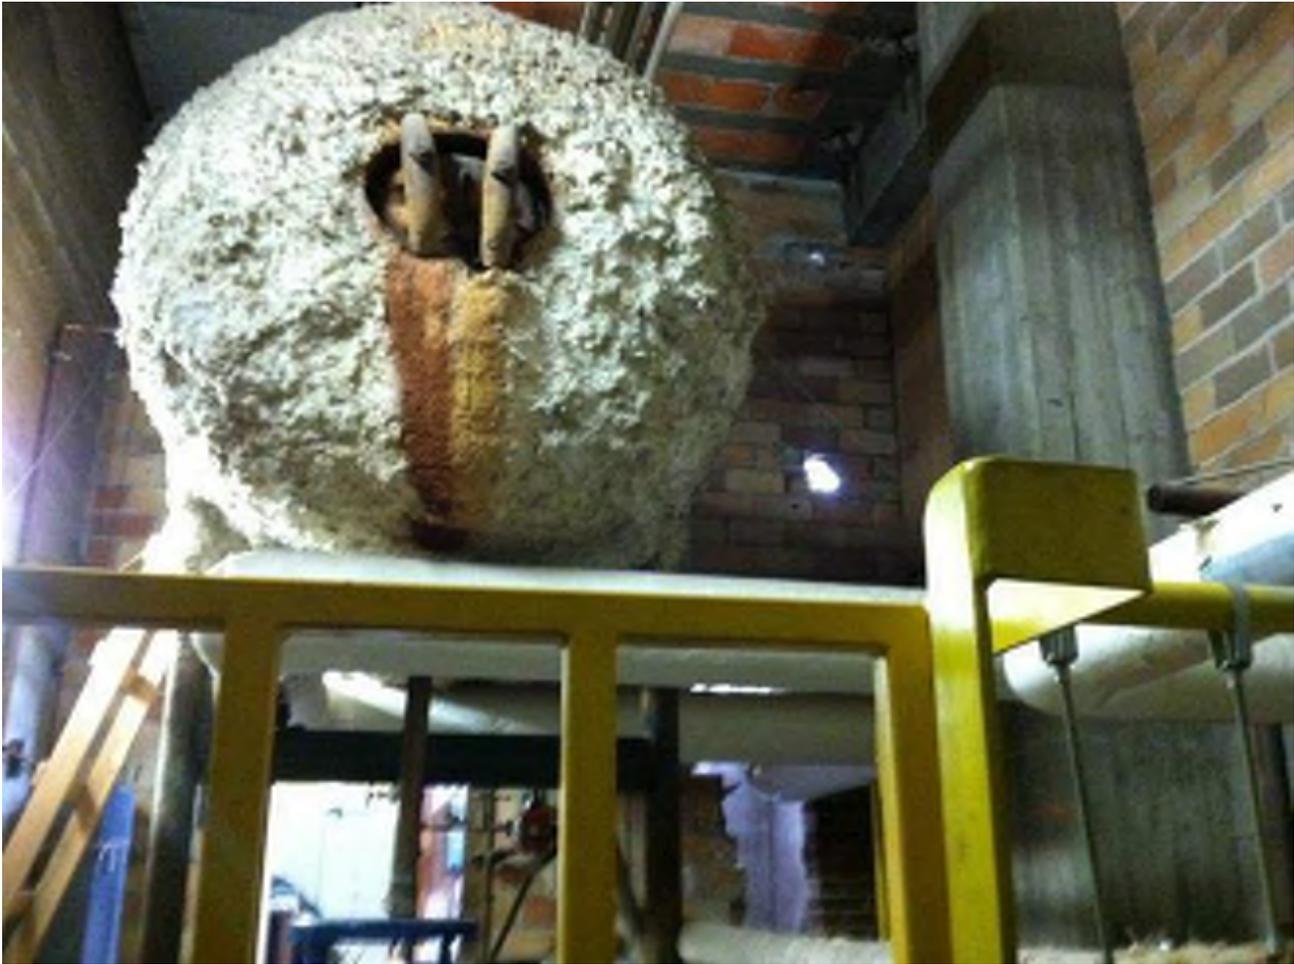
Overall the plumbing systems are original to the building and have exceeded their life expectancy. As plumbing systems age water hardness and quality can plug or corrode piping and ultimately lead to piping failure. There are several areas of pipe replacement of the years and these areas are in good to fair condition. The domestic hot water systems are inefficient in regards to energy as storing nearly 1,000 gallons for minimal hot water usage can be energy intensive. The existing plumbing fixtures in most cases are original to

Figure 107: Existing hot water storage tank in the southeast lower level of Romney Gym.

It is recommended that the entire plumbing system be removed from the building. New, updated plumbing piping and fixtures should be installed and appropriate pipe routing will be required. It may be cost effective to utilize the existing waste entrance piping as this piping is well below the lower slab of the building. This piping would need to be investigated with a camera to verify that it is in good enough condition to be reused. It is also recommended that an appropriately sized energy efficient domestic hot water system be installed.

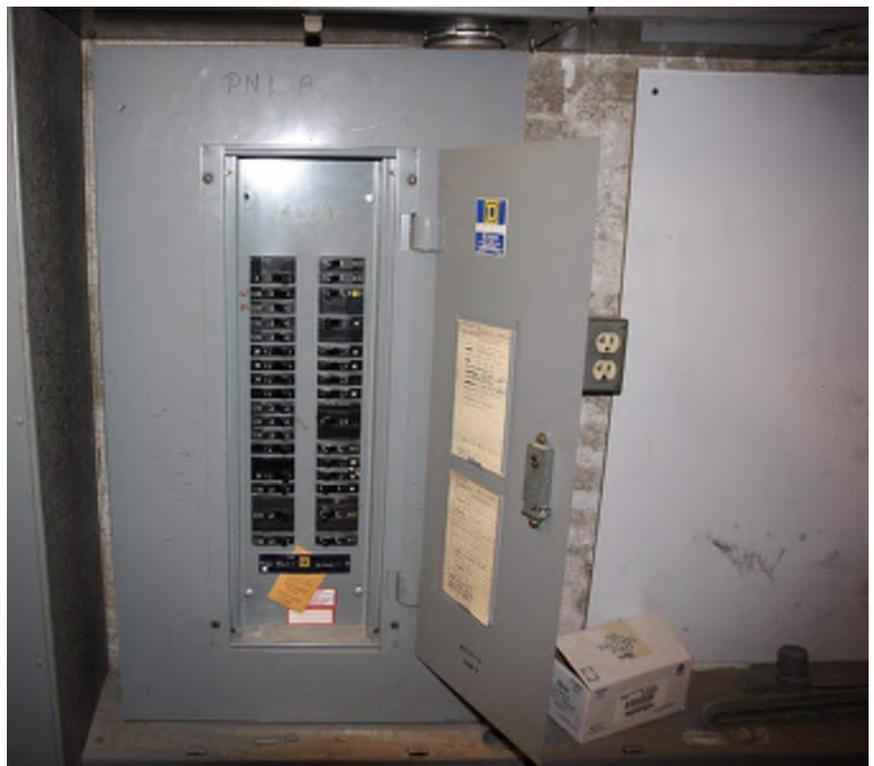
Figure 108: Panelboard A.

Overall, the branch circuits and wiring devices are in fair/poor condition. The facility does not have an adequate quantity of receptacles.

Complete replacement of the branch circuits and wiring devices is recommended.

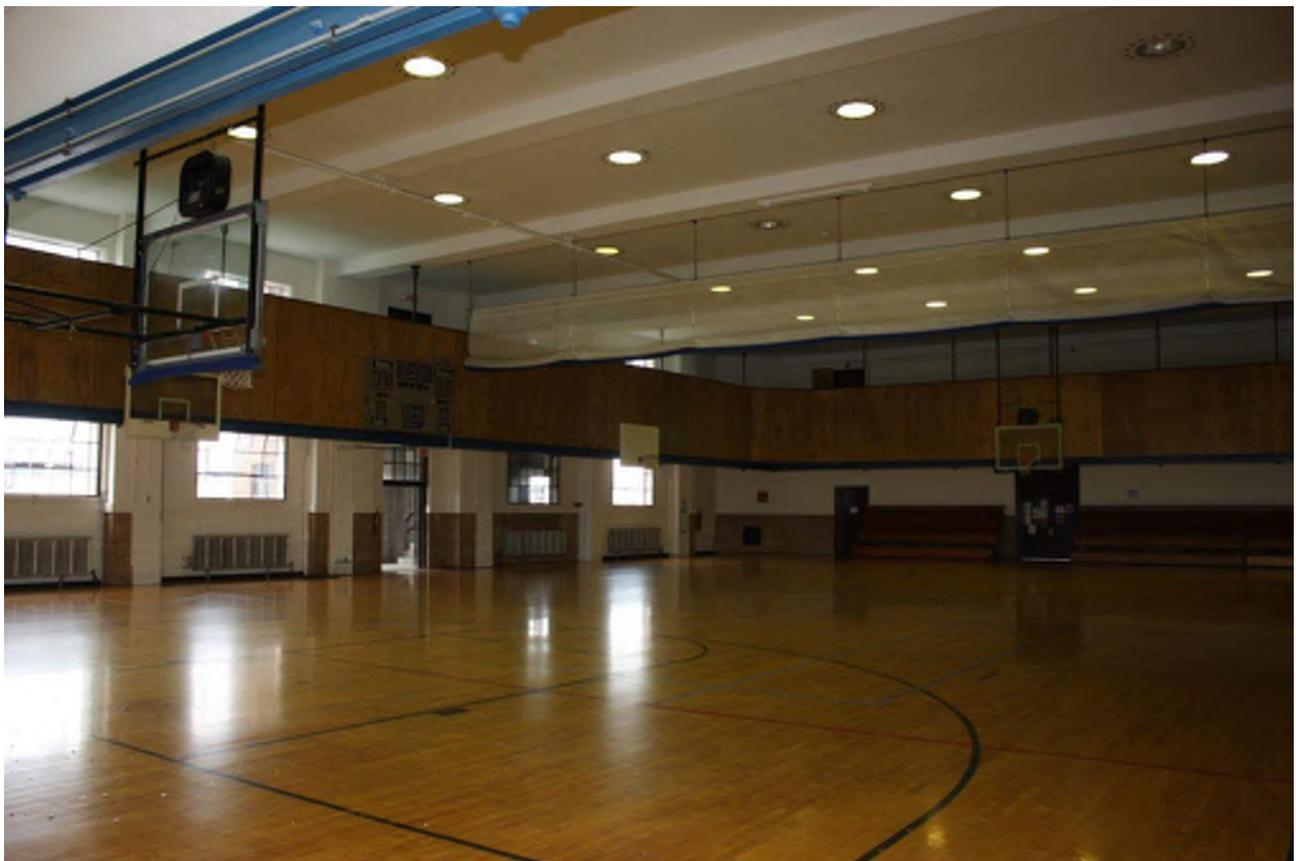
Overall the lighting throughout the facility is in very poor condition and has very poor energy efficiency. The T12 lamps are obsolete and no longer manufactured. Many of the fixtures do not fit the historic character of the facility.

Figure 109: The Main Gym has high-bay style light fixtures with metal halide lamps.

The lighting should be replaced in its entirety with new high efficient lighting and control strategies that incorporate occupancy sensor controls and daylight harvesting. Upgrading the lighting can reduce the energy
